Access Compliance Report

Public Rights-of-Way

(Curb Ramps)

Intersection ID: N/A	Main Street: MCKEE_RD	Cross Street: N/A	Location: NW
ADA ID: F6BB685F0AEC	Ramp Type: PerpDiag	Initial Pass/Fail: Fail	Overall Compliance: No
Codes/Mitigation Info/Possible Solution		Field Measurements/Component Compliance	
Severity Score: 8.75

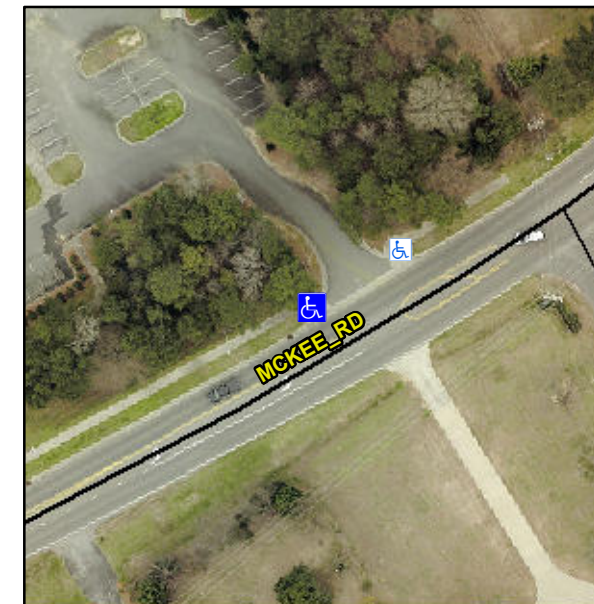
Not Found, R304.5.1

Compliance	Description	Data	Compliance	Description	Data
N/A	Ramp Length (in)	69.0	Yes	Ramp Slope (%)	7.4
No	Ramp Width (in)	47.0	Yes	Ramp XSlope (%)	1.8
N/A	Flare Type LT	N/A	N/A	Flare Type RT	N/A
N/A	Flare Slope LT (%)	N/A	N/A	Flare Slope RT (%)	N/A
N/A	Flare Traversable LT?	N/A	N/A	Flare Traversable RT?	N/A
N/A	Landing Length (in)	N/A	N/A	DWS Provided?	N/A
N/A	Landing Width (in)	N/A	N/A	DWS Contrast?	N/A
N/A	Landing Slope (%)	N/A	N/A	DWS Length (in)	N/A
N/A	Landing X Slope (%)	N/A	N/A	DWS Full Width?	N/A
N/A	Landing Curb? (Y/N)	N/A	N/A	DWS Offset (in)	N/A
N/A	Shared Landing?	N/A			
N/A	Gutter Ponding?	N/A	N/A	Gutter Slope (%)	N/A
N/A	Gutter Lip Ht (in)	N/A	N/A	Gutter X Slope (%)	N/A
N/A	Painted X Walk1?	No	N/A	Painted X Walk2?	No
	X Walk 1 Direction	To S		X Walk 2 Direction	To E
N/A	X Walk 1 Width (in)	N/A	N/A	X Walk 2 Width (in)	N/A
	X Walk 1 Slope (%)	3.0		X Walk 2 Slope (%)	4.2
	X Walk 1 X Slope (%)	0.9		X Walk 2 X Slope (%)	2.3

N/A	Ramp inside XWalk1?	N/A	N/A	Ramp inside XWalk2?	N/A
	Road Slope (%)	1.2	N/A	Clear Space?	N/A
	Road X Slope (%)	1.7	N/A	Clear Space to XWalk (in)	N/A
N/A	Any Obstructions?	N/A	N/A	Storm Grate/Utility Hazard?	N/A
	Obstruction Type			Storm Grate/Utility Type	
		N/A			N/A
			Yes	Surface Condition? (G/P)	Good

Remove & Replace Curb Ramp With Two New Directional Ramps or Equivalent.
