# Access Compliance Report

## Public Rights-of-Way

### (Curb Ramps)

Intersection ID: 47571	Main Street: SEDGEBURN_DR	Cross Street: HERMSLEY_RD	Location: NE
ADA ID: F6D44D7336B5	Ramp Type: PerpDiag	Initial Pass/Fail: Fail	Overall Compliance: No
		Severity Score: 22.5

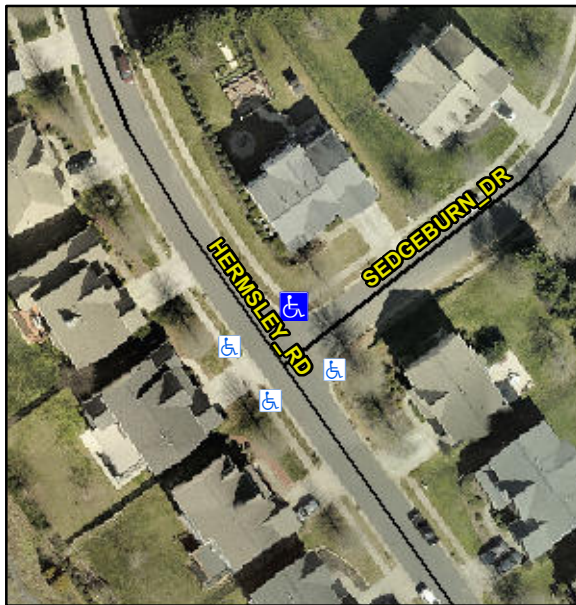
Compliance	Description	Data	Compliance	Description	Data
N/A	Ramp Length (in)	49.0	No	Ramp Slope (%)	8.8
No	Ramp Width (in)	43.0	No	Ramp XSlope (%)	2.8
N/A	Flare Type LT	N/A	N/A	Flare Type RT	N/A
N/A	Flare Slope LT (%)	N/A	N/A	Flare Slope RT (%)	N/A
N/A	Flare Traversable LT?	N/A	N/A	Flare Traversable RT?	N/A
N/A	Landing Length (in)	N/A	N/A	DWS Provided?	N/A
N/A	Landing Width (in)	N/A	N/A	DWS Contrast?	N/A
N/A	Landing Slope (%)	N/A	N/A	DWS Length (in)	N/A
N/A	Landing X Slope (%)	N/A	N/A	DWS Full Width?	N/A
N/A	Landing Curb? (Y/N)	N/A	N/A	DWS Offset (in)	N/A
N/A	Shared Landing?	N/A			
N/A	Gutter Ponding?	N/A	N/A	Gutter Slope (%)	N/A
N/A	Gutter Lip Ht (in)	N/A	N/A	Gutter X Slope (%)	N/A
N/A	Painted X Walk1?	No	N/A	Painted X Walk2?	No
	X Walk 1 Direction	To SW		X Walk 2 Direction	To SE
N/A	X Walk 1 Width (in)	N/A	N/A	X Walk 2 Width (in)	N/A
	X Walk 1 Slope (%)	1.3		X Walk 2 Slope (%)	6.9
	X Walk 1 X Slope (%)	5.9		X Walk 2 X Slope (%)	2.3

N/A	Ramp inside XWalk1?	N/A	N/A	Ramp inside XWalk2?	N/A
	Road Slope (%)	2.5	N/A	Clear Space?	N/A
	Road X Slope (%)	3.9	N/A	Clear Space to XWalk (in)	N/A
N/A	Any Obstructions?	N/A	N/A	Storm Grate/Utility Hazard?	N/A
	Obstruction Type			Storm Grate/Utility Type	
		N/A			N/A
			Yes	Surface Condition? (G/P)	Good

**Remove & Replace Curb Ramp With Two New Directional Ramps or Equivalent.**

Total Cost: \$ 3200.00
