# Access Compliance Report

## Public Rights-of-Way

### (Curb Ramps)

Intersection ID: 31626	Main Street: PLAZA_WALK_DR	Cross Street: THE_PLAZA	Location: SE
ADA ID: F6DF8CC9E17B	Ramp Type: BlendTrans1	Initial Pass/Fail: Fail	Overall Compliance: No
Severity Score: 21.25			
Codes/Mitigation Info/Possible Solution		Field Measurements/Component Compliance

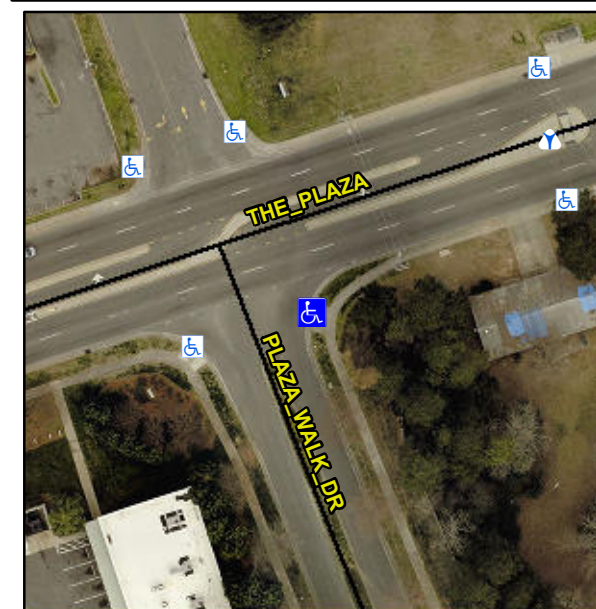
**Not Found, R304.5.1, R304.5.3**

Compliance	Description	Data	Compliance	Description	Data
N/A	Ramp Length (in)	97.0	Yes	BlendTrans Slope (%)	3.4
No	Ramp Width (in)	41.0	No	BlendTrans XSlope (%)	5.5
N/A	Flare Type LT	N/A	N/A	Flare Type RT	N/A
N/A	Flare Slope LT (%)	N/A	N/A	Flare Slope RT (%)	N/A
N/A	Flare Traversable LT?	N/A	N/A	Flare Traversable RT?	N/A
N/A	Landing Length (in)	N/A	N/A	DWS Provided?	N/A
N/A	Landing Width (in)	N/A	N/A	DWS Contrast?	N/A
N/A	Landing Slope (%)	N/A	N/A	DWS Length (in)	N/A
N/A	Landing X Slope (%)	N/A	N/A	DWS Full Width?	N/A
N/A	Landing Curb? (Y/N)	N/A	N/A	DWS Offset (in)	N/A
N/A	Shared Landing?	N/A			
N/A	Gutter Ponding?	N/A	N/A	Gutter Slope (%)	N/A
N/A	Gutter Lip Ht (in)	0.5	N/A	Gutter X Slope (%)	N/A
N/A	Painted X Walk1?	No	N/A	Painted X Walk2?	N/A
	X Walk 1 Direction	To SW		X Walk 2 Direction	N/A
	X Walk 1 Width (in)	N/A		X Walk 2 Width (in)	N/A
	X Walk 1 Slope (%)	0.2		X Walk 2 Slope (%)	N/A
	X Walk 1 X Slope (%)	2.8		X Walk 2 X Slope (%)	N/A

N/A	Ramp inside XWalk1?	N/A	N/A	Ramp inside XWalk2?	N/A
	Road Slope (%)	2.8		Clear Space?	N/A
	Road X Slope (%)	0.2	N/A	Clear Space to XWalk (in)	N/A
N/A	Any Obstructions?	N/A	N/A	Storm Grate/Utility Hazard?	N/A
	Obstruction Type			Storm Grate/Utility Type	
		N/A			N/A
			Yes	Surface Condition? (G/P)	Good
			No	Curb Slope (%)	14.0

**Remove & Replace Curb Ramp With Two New Directional Ramps or Equivalent.**
