# Access Compliance Report

## Public Rights-of-Way

### (Curb Ramps)

| Intersection ID: 10032938 | Main Street: NEW_BERN_ST | Cross Street: N/A | Location: | N |

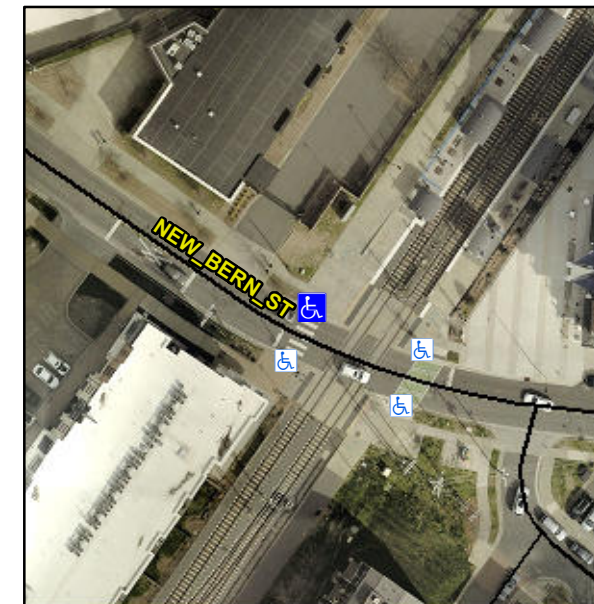
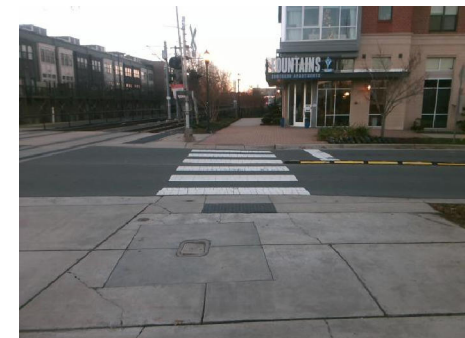
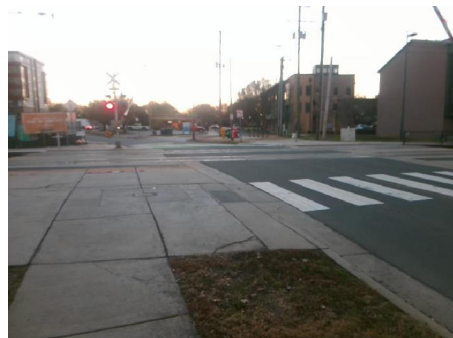
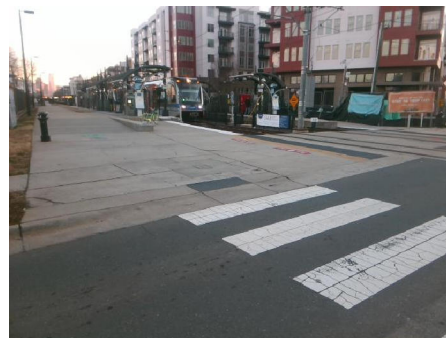
| ADA ID: F6E831F39DEF | Ramp Type: BlendTrans1 | Initial Pass/Fail: Pass | Overall Compliance: No | Severity Score: 0 |

| Compliance | Description | Data | Compliance | Description | Data |
|---|---|---|---|---|---|
| N/A | Flare Slope LT (%) | 1.4 | Yes | Flare Slope RT (%) | 4.9 |
| N/A | Flare Traversable LT? | No | N/A | Flare Traversable RT? | Yes |
| | | | No | Curb Slope (%) | 20.8 |

**Remove & Replace Curb Slope and Extend Ramp.**

Total Cost: \$ 2000.00
