# Access Compliance Report

## Public Rights-of-Way

### (Curb Ramps)

Intersection ID: 24540	Main Street: BIRNEN_DR	Cross Street: CAMERON_WOOD_DR	Location: W
ADA ID: F6F2F975095D	Ramp Type: Perp	Initial Pass/Fail: Fail	Overall Compliance: No
Severity Score: 22.5			
Codes/Mitigation Info/Possible Solution		Field Measurements/Component Compliance

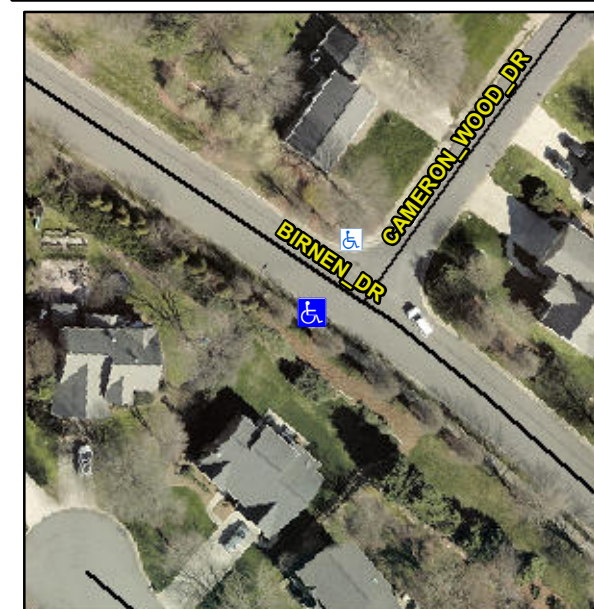
**Not Found, R304.5.1, R304.2.2**

Compliance	Description	Data	Compliance	Description	Data
N/A	Ramp Length (in)	50.0	No	Ramp Slope (%)	11.5
No	Ramp Width (in)	47.0	Yes	Ramp XSlope (%)	2.5
N/A	Flare Type LT	N/A	N/A	Flare Type RT	N/A
N/A	Flare Slope LT (%)	N/A	N/A	Flare Slope RT (%)	N/A
N/A	Flare Traversable LT?	N/A	N/A	Flare Traversable RT?	N/A
N/A	Landing Length (in)	N/A	N/A	DWS Provided?	N/A
N/A	Landing Width (in)	N/A	N/A	DWS Contrast?	N/A
N/A	Landing Slope (%)	N/A	N/A	DWS Length (in)	N/A
N/A	Landing X Slope (%)	N/A	N/A	DWS Full Width?	N/A
N/A	Landing Curb? (Y/N)	N/A	N/A	DWS Offset (in)	N/A
N/A	Shared Landing?	N/A			
N/A	Gutter Ponding?	N/A	N/A	Gutter Slope (%)	N/A
N/A	Gutter Lip Ht (in)	N/A	N/A	Gutter X Slope (%)	N/A
N/A	Painted X Walk1?	No	N/A	Painted X Walk2?	N/A
	X Walk 1 Direction	To NE		X Walk 2 Direction	N/A
N/A	X Walk 1 Width (in)	N/A	N/A	X Walk 2 Width (in)	N/A
	X Walk 1 Slope (%)	5.1		X Walk 2 Slope (%)	N/A
	X Walk 1 X Slope (%)	2.5		X Walk 2 X Slope (%)	N/A

N/A	Ramp inside XWalk1?	N/A	N/A	Ramp inside XWalk2?	N/A
	Road Slope (%)	N/A	N/A	Clear Space?	N/A
	Road X Slope (%)	N/A	N/A	Clear Space to XWalk (in)	N/A
N/A	Any Obstructions?	N/A	N/A	Storm Grate/Utility Hazard?	N/A
	Obstruction Type			Storm Grate/Utility Type	
		N/A			N/A
			Yes	Surface Condition? (G/P)	Good

Possible Solutions:

**Remove & Replace Entire Ramp.**

Total Cost: \$ 1850.00
