Access Compliance Report

Public Rights-of-Way

(Curb Ramps)

Intersection ID: N/A	Main Street: MCVAY_ST	Cross Street: HEFLIN_ST	Location: W
ADA ID: F7097CF12AB6	Ramp Type: Directional1	Initial Pass/Fail: Fail	Overall Compliance: No
Severity Score: 12.5			
Codes/Mitigation Info/Possible Solution		Field Measurements/Component Compliance

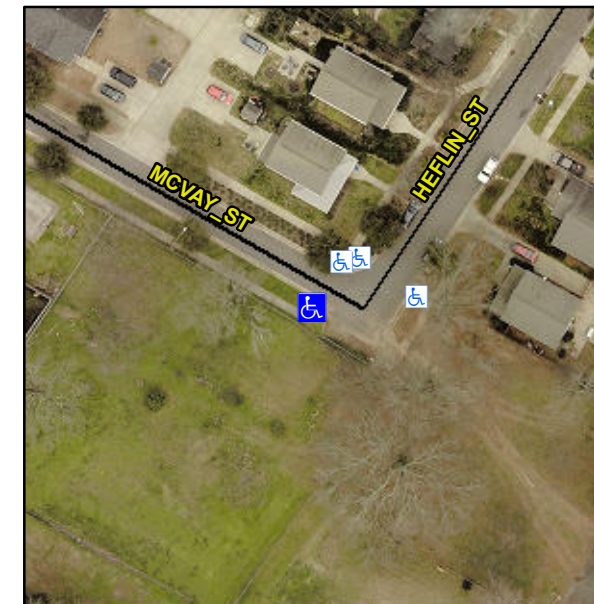
Compliance	Description	Data	Compliance	Description	Data
N/A	Ramp Length (in)	72.0	N/A	Grade Break?	N/A
Yes	Ramp Width (in)	58.0	N/A	Grade Break Slope (%)	0.0
No	Ramp Slope (%)	8.7	N/A	Grade Break XSlope (%)	0.0
Yes	Ramp XSlope (%)	0.4			
N/A	Flare Type LT	N/A	N/A	Flare Type RT	N/A
N/A	Flare Slope LT (%)	N/A	N/A	Flare Slope RT (%)	0.0
N/A	Flare Traversable LT?	N/A	N/A	Flare Traversable RT?	N/A
N/A	Landing Length (in)	0.0	N/A	DWS Provided?	N/A
N/A	Landing Width (in)	0.0	N/A	DWS Contrast?	N/A
N/A	Landing Slope (%)	0.0	N/A	DWS Length (in)	N/A
N/A	Landing X Slope (%)	0.0	N/A	DWS Full Width?	N/A
N/A	Landing Curb? (Y/N)	N/A	N/A	DWS Offset LT (in)	N/A
N/A	Shared Landing?	N/A	N/A	DWS Offset RT (in)	N/A
N/A	Gutter Ponding?	0.0	N/A	Gutter Slope (%)	N/A
N/A	Gutter Lip Ht (in)	0.0	N/A	Gutter X Slope (%)	N/A
N/A	Painted X Walk1?	No		Road Slope (%)	2.3
	X Walk 1 Direction	To N		Road X Slope (%)	1.4
	X Walk 1 Width (in)	N/A		Clear Space?	N/A

X Walk 1 Slope (%)	2.3	N/A	Clear Space to XWalk (in)	N/A
	X Walk 1 X Slope (%)	1.4	N/A	Storm Grate/Utility Hazard?	N/A
N/A	Ramp inside XWalk1?	N/A		Storm Grate/Utility Type	
N/A	Any Obstructions?	N/A			N/A
	Obstruction Type		Yes	Surface Condition? (G/P)	Good
			N/A	Curb Slope (%)	23.8

Possible Solutions:

Remove & Replace Entire Ramp.
