Access Compliance Report

Public Rights-of-Way

(Curb Ramps)

Intersection ID: 9879	Main Street: PATTON_AV	Cross Street: CREEK_ST	Location: SW
ADA ID: F70CDE9B8811	Ramp Type: Directional1	Initial Pass/Fail: Fail	Overall Compliance: No
		Severity Score: 1.25

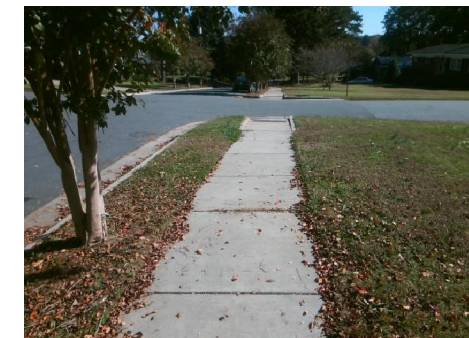
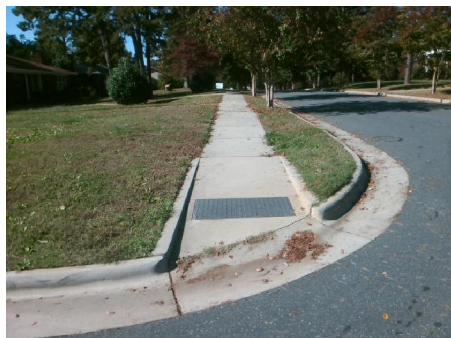
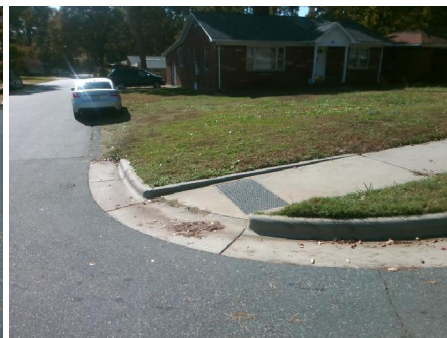
R304.5.3

Compliance	Description	Data	Compliance	Description	Data
N/A	Ramp Length (in)	366.0	N/A	Grade Break?	N/A
Yes	Ramp Width (in)	58.5	N/A	Grade Break Slope (%)	0.0
Yes	Ramp Slope (%)	7.6	N/A	Grade Break XSlope (%)	0.0
No	Ramp XSlope (%)	3.6			
N/A	Flare Type LT	N/A	N/A	Flare Type RT	N/A
N/A	Flare Slope LT (%)	N/A	N/A	Flare Slope RT (%)	0.0
N/A	Flare Traversable LT?	N/A	N/A	Flare Traversable RT?	N/A
N/A	Landing Length (in)	0.0	N/A	DWS Provided?	N/A
N/A	Landing Width (in)	0.0	N/A	DWS Contrast?	N/A
N/A	Landing Slope (%)	0.0	N/A	DWS Length (in)	N/A
N/A	Landing X Slope (%)	0.0	N/A	DWS Full Width?	N/A
N/A	Landing Curb? (Y/N)	N/A	N/A	DWS Offset LT (in)	N/A
N/A	Shared Landing?	N/A	N/A	DWS Offset RT (in)	N/A
N/A	Gutter Ponding?	0.0	N/A	Gutter Slope (%)	N/A
N/A	Gutter Lip Ht (in)	0.0	N/A	Gutter X Slope (%)	N/A
N/A	Painted X Walk1?	No		Road Slope (%)	2.4
	X Walk 1 Direction	To SE		Road X Slope (%)	0.8
	X Walk 1 Width (in)	N/A		Clear Space?	N/A

X Walk 1 Slope (%)	2.4	N/A	Clear Space to XWalk (in)	N/A
	X Walk 1 X Slope (%)	0.8	N/A	Storm Grate/Utility Hazard?	N/A
N/A	Ramp inside XWalk1?	N/A		Storm Grate/Utility Type	
N/A	Any Obstructions?	N/A			N/A
	Obstruction Type		Yes	Surface Condition? (G/P)	Good
			N/A	Curb Slope (%)	21.0

Remove & Replace Entire Ramp.

Total Cost: \$ 1600.00
