Access Compliance Report

Public Rights-of-Way

(Curb Ramps)

Intersection ID: 20116		Main Street: BARCLAY_DOWNS_DR		Cross Street: BULFINCH_RD		Location: SW							
ADA ID: F70EA68256C8		Ramp Type: Directional1		Initial Pass/Fail: Fail		Overall Compliance: No		Severity Score: 22.5					
Codes/Mitigation Info/Possible Solution				Field Measurements/Component Compliance									
<div>

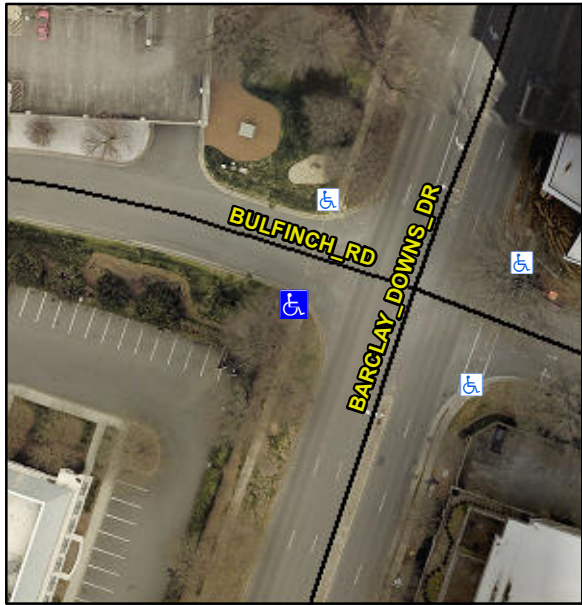
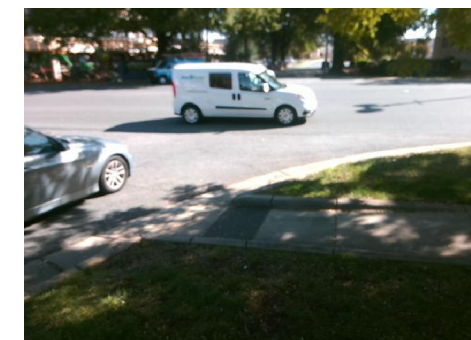
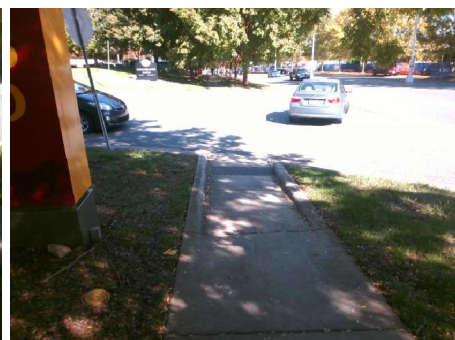
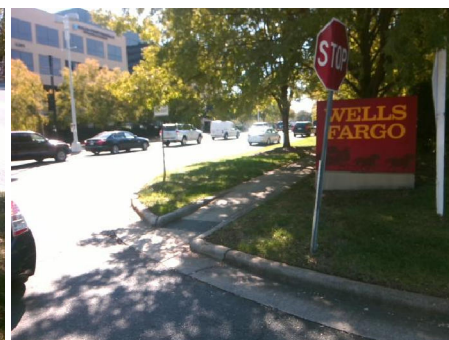
</div> <div>Possible Solutions: Remove & Replace Entire Ramp.</div> <div>Surveyor Notes: N/A</div> <div>PROW/ADA: R304.5.1, R304.2.2, R304.5.3</div> <div><div>Street 1 Name</div><div>BULFINCH RD</div><div>Stop Condition-Street 1</div><div>StopSign</div><div>Street 2 Name</div><div>N/A</div><div>Stop Condition-Street 2</div><div>N/A</div></div>				Compliance	Description	Data	Compliance	Description	Data				
				N/A	Ramp Length (in)	120.0	N/A	Grade Break?	N/A				
				No	Ramp Width (in)	45.0	N/A	Grade Break Slope (%)	0.0				
				No	Ramp Slope (%)	8.9	N/A	Grade Break XSlope (%)	0.0

No	Ramp XSlope (%)	3.8							
				N/A	Flare Type LT	N/A	N/A	Flare Type RT	N/A				
				N/A	Flare Slope LT (%)	N/A	N/A	Flare Slope RT (%)	0.0				
				N/A	Flare Traversable LT?	N/A	N/A	Flare Traversable RT?	N/A				
				N/A	Landing Length (in)	0.0	N/A	DWS Provided?	N/A				
				N/A	Landing Width (in)	0.0	N/A	DWS Contrast?	N/A				
				N/A	Landing Slope (%)	0.0	N/A	DWS Length (in)	N/A				
				N/A	Landing X Slope (%)	0.0	N/A	DWS Full Width?	N/A				
				N/A	Landing Curb? (Y/N)	N/A	N/A	DWS Offset LT (in)	N/A				
				N/A	Shared Landing?	N/A	N/A	DWS Offset RT (in)	N/A				
				N/A	Gutter Ponding?	0.0	N/A	Gutter Slope (%)	N/A				
				N/A	Gutter Lip Ht (in)	0.0	N/A	Gutter X Slope (%)	N/A				
				N/A	Painted X Walk1?	No		Road Slope (%)	4.3				
					X Walk 1 Direction	To N		Road X Slope (%)	2.6				
					X Walk 1 Width (in)	N/A		Clear Space?	N/A				
					X Walk 1 Slope (%)	4.3	N/A	Clear Space to XWalk (in)	N/A				
					X Walk 1 X Slope (%)	2.6	N/A	Storm Grate/Utility Hazard?	N/A

N/A	Ramp inside XWalk1?	N/A		Storm Grate/Utility Type					
				N/A	Any Obstructions?	N/A			N/A				
					Obstruction Type		Yes	Surface Condition? (G/P)	Good				
							N/A	Curb Slope (%)	4.1				
				Total Cost:				\$	1600.00
