Access Compliance Report

Public Rights-of-Way

(Curb Ramps)

Intersection ID: 13736	Main Street: CAMDEN_RD	Cross Street: E_PARK_AV	Location: W
ADA ID: F714053E9795	Ramp Type: Perp	Initial Pass/Fail: Fail	Overall Compliance: No
Severity Score: 10			
Codes/Mitigation Info/Possible Solution		Field Measurements/Component Compliance

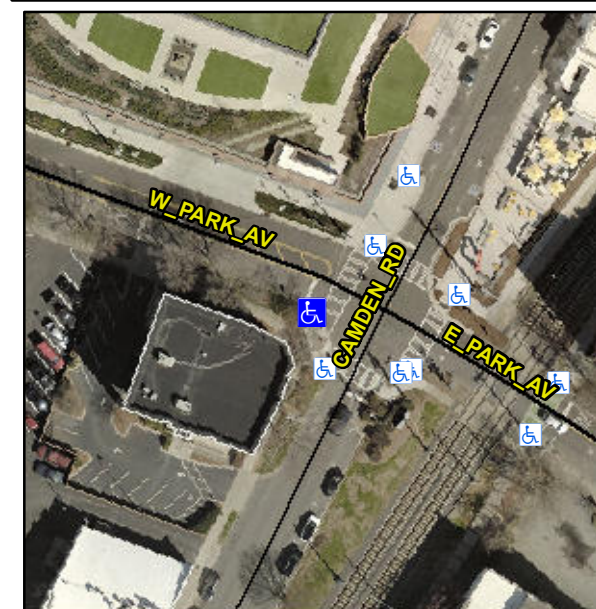
Not Found, R304.5.1

Compliance	Description	Data	Compliance	Description	Data
N/A	Ramp Length (in)	72.0	Yes	Ramp Slope (%)	8.0
No	Ramp Width (in)	47.0	Yes	Ramp XSlope (%)	3.6
N/A	Flare Type LT	N/A	N/A	Flare Type RT	N/A
N/A	Flare Slope LT (%)	N/A	N/A	Flare Slope RT (%)	N/A
N/A	Flare Traversable LT?	N/A	N/A	Flare Traversable RT?	N/A
N/A	Landing Length (in)	N/A	N/A	DWS Provided?	N/A
N/A	Landing Width (in)	N/A	N/A	DWS Contrast?	N/A
N/A	Landing Slope (%)	N/A	N/A	DWS Length (in)	N/A
N/A	Landing X Slope (%)	N/A	N/A	DWS Full Width?	N/A
N/A	Landing Curb? (Y/N)	N/A	N/A	DWS Offset (in)	N/A
N/A	Shared Landing?	N/A			
N/A	Gutter Ponding?	N/A	N/A	Gutter Slope (%)	N/A
N/A	Gutter Lip Ht (in)	N/A	N/A	Gutter X Slope (%)	N/A
N/A	Painted X Walk1?	Yes	N/A	Painted X Walk2?	N/A
	X Walk 1 Direction	To NE		X Walk 2 Direction	N/A
N/A	X Walk 1 Width (in)	105.0	N/A	X Walk 2 Width (in)	N/A
	X Walk 1 Slope (%)	3.2		X Walk 2 Slope (%)	N/A
	X Walk 1 X Slope (%)	4.2		X Walk 2 X Slope (%)	N/A

N/A	Ramp inside XWalk1?	Yes	N/A	Ramp inside XWalk2?	N/A
	Road Slope (%)	N/A	N/A	Clear Space?	N/A
	Road X Slope (%)	N/A	N/A	Clear Space to XWalk (in)	N/A
N/A	Any Obstructions?	N/A	N/A	Storm Grate/Utility Hazard?	N/A
	Obstruction Type			Storm Grate/Utility Type	
		N/A			N/A
		Yes		Surface Condition? (G/P)	Good

Remove & Replace Entire Ramp.
