# Access Compliance Report

## Public Rights-of-Way (Curb Ramps)

| Intersection ID: N/A | Main Street: CITY_PARK_DR | Cross Street: N/A | Location: NW |
| ADA ID: F71D3D08235F | Ramp Type: BlendTrans1 | Initial Pass/Fail: Pass | Overall Compliance: No |

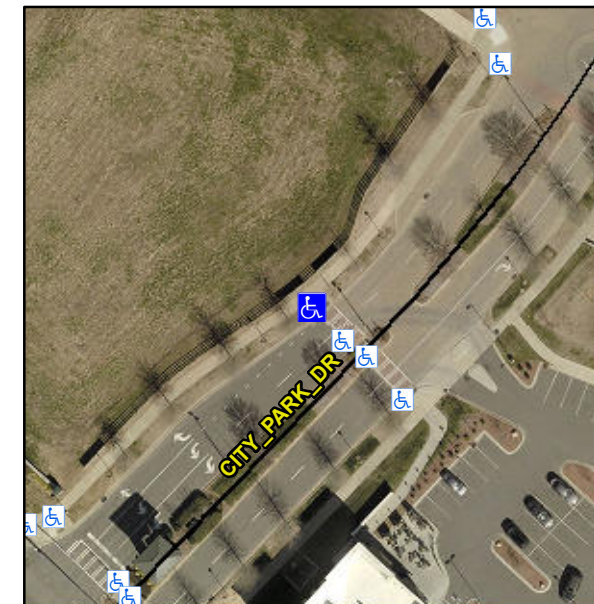
**Not Found, R304.2.2-Perp, R304.3.2-Para, R305.1.4, R302.7.2, R304.5.4**

| Compliance | Description | Data | Compliance | Description | Data |
|---|---|---|---|---|---|
| No | Landing Slope (%) | 3.8 | Yes | DWS Length (in) | 24.0 |
| Yes | Landing X Slope (%) | 1.0 | No | DWS Full Width? | No |
| Yes | Gutter Ponding? | No | No | Gutter Slope (%) | 10.3 |
| No | Gutter Lip Ht (in) | 1.0 | Yes | Gutter X Slope (%) | 0.4 |
| | | | No | Curb Slope (%) | 8.5 |

Possible Solutions:

**Remove & Replace Curb Ramp With Two New Directional Ramps or Equivalent. Remove & Replace Gutter.**
