Intersection ID: 18333 Main Street: BIEMANN_VALLEY_DR Cross Street: JALDENA_DR Location: SE

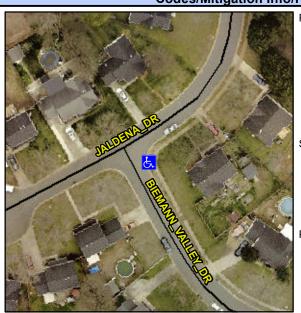
ADA ID: F71DB6368D7F Ramp Type: PerpDiag Initial Pass/Fail: Fail Overall Compliance: No Severity Score: 17.5

Not Found, R304.5.1

Field Measurements/Component Compilance						
Compliance Description		Data	Compl	iance	Description	Data
N/A	Ramp Length (in)	94.0	Yes	Ramp	Slope (%)	7.8
No	Ramp Width (in)	35.0	Yes	Ramp	XSlope (%)	1.8
N/A	Flare Type LT	N/A	N/A Flare Type RT		N/A	
N/A	Flare Slope LT (%)	N/A	N/A Flare Slope RT (%)		N/A	
N/A	Flare Traversable LT?	N/A	N/A	Flare	Traversable RT?	N/A
N/A	Landing Length (in)	N/A	N/A	DWS	Provided?	N/A
N/A	Landing Width (in)	N/A	N/A	DWS	Contrast?	N/A
N/A	Landing Slope (%)	N/A	N/A	DWS	Length (in)	N/A
N/A	Landing X Slope (%)	N/A	N/A	DWS	Full Width?	N/A
N/A	Landing Curb? (Y/N)	N/A	N/A	DWS	Offset (in)	N/A
N/A	Shared Landing?	N/A				
N/A	Gutter Ponding?	N/A	N/A	Gutte	er Slope (%)	N/A
N/A	Gutter Lip Ht (in)	N/A	N/A	Gutte	er X Slope (%)	N/A
N/A	Painted X Walk1?	No	N/A	Paint	ed X Walk2?	No
	X Walk 1 Direction	To N		X Wa	lk 2 Direction	To W
N/A	X Walk 1 Width (in)	N/A	N/A	X Wa	lk 2 Width (in)	N/A
	X Walk 1 Slope (%)	3.4		X Wa	lk 2 Slope (%)	0.1

X Walk 1 X Slope (%)	0.4		X Wa	lk 2 X Slope (%)	3.8
N/A	Ramp inside XWalk1?	N/A	N/A	Ram	o inside XWalk2?	N/A
	Road Slope (%)	4.2	N/A	Clear	Space?	N/A
	Road X Slope (%)	2.2	N/A	Clear	Space to XWalk (in)	N/A
N/A	Any Obstructions?	N/A	N/A	Storn	n Grate/Utility Hazard?	N/A

JALDENA DR None BIEMANN VALLEY DR StopSign Possible Solutions:

Remove & Replace Curb Ramp With
Two New Directional Ramps or
Equivalent.
