Access Compliance Report Public Rights-of-Way (Curb Ramps)

Intersection ID: 6542Main Street:DEVAS_CTCross Street:MISTY_CREEK_DRLocation:NWADA ID: F72BAE5972E9Ramp Type:PerpInitial Pass/Fail:FailOverall Compliance:NoSeverity Score:10

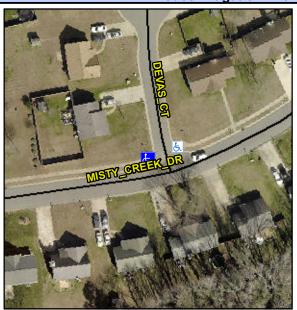
Field Measurements/Component Compliance						
Compl	iance Description	Data	Comp	liance Description	Data	
N/A	Ramp Length (in)	96.5	Yes	Ramp Slope (%)	8.2	
No	Ramp Width (in)	46.0	No	Ramp XSlope (%)	2.9	
N/A	Flare Type LT	N/A	N/A	Flare Type RT	N/A	
N/A	Flare Slope LT (%)	N/A	N/A	Flare Slope RT (%)	N/A	
N/A	Flare Traversable LT?	N/A	N/A	Flare Traversable RT?	N/A	
N/A	Landing Length (in)	N/A	N/A	DWS Provided?	N/A	
N/A	Landing Width (in)	N/A	N/A	DWS Contrast?	N/A	
N/A	Landing Slope (%)	N/A	N/A	DWS Length (in)	N/A	
N/A	Landing X Slope (%)	N/A	N/A	DWS Full Width?	N/A	
N/A	Landing Curb? (Y/N)	N/A	N/A	DWS Offset (in)	N/A	
N/A	Shared Landing?	N/A				
N/A	Gutter Ponding?	N/A	N/A	Gutter Slope (%)	N/A	
N/A	Gutter Lip Ht (in)	N/A	N/A	Gutter X Slope (%)	N/A	
N/A	Painted X Walk1?	No	N/A	Painted X Walk2?	N/A	
	X Walk 1 Direction	То Е		X Walk 2 Direction	N/A	
N/A	X Walk 1 Width (in)	N/A	N/A	X Walk 2 Width (in)	N/A	
	X Walk 1 Slope (%)	1.0		X Walk 2 Slope (%)	N/A

X Walk 1 X Slope (%)	0.2		X Walk 2 X Slope (%)	N/A	
N/A	Ramp inside XWalk1?	N/A	N/A	Ramp inside XWalk2?	N/A	
	Road Slope (%)	N/A	N/A	Clear Space?	N/A	
	Road X Slope (%)	N/A	N/A	Clear Space to XWalk (in)	N/A	
N/A	Any Obstructions?	N/A	N/A	Storm Grate/Utility Hazard?	N/A	
	Obstruction Type			Storm Grate/Utility Type		
		N/A			N/A	
			Yes	Surface Condition? (G/P)	Good

71 CCCIDIO CCIALICII	
Possible Solutions:	<u>c</u>
Remove & Replace Entire Ramp.	N
	N
	N
	N
	N
	N
Surveyor Notes:	N
N/A	N
	N
	N
	N
PROW/ADA:	N
Not Found, R304.5.1, R304.5.3	N
	N
	N
	N

1850.00
