Access Compliance Report Public Rights-of-Way (Curb Ramps)

Intersection ID: 5523Main Street:MALLARD_PARK_DRCross Street:PINE_BRANCH_CTLocation:WADA ID: F72C1819B72CRamp Type:PerpInitial Pass/Fail:FailOverall Compliance:NoSeverity Score:36.25

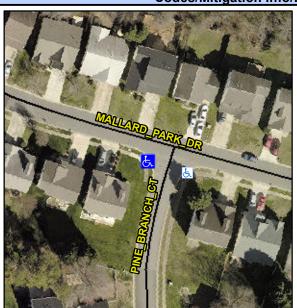
| Possible Solutions: | <u> </u> |
|---|---|
| Not Found, R304.5.1, R304.5.3 | N |

| Field Measurements/Component Compliance | | | | | | | | |
|---|---|---|---|---|---|---|--|--|
| N/A | Ramp Length (in) | 96.0 | Yes | Ramp | Slope (%) | 7.3 | | |
| No | Ramp Width (in) | 28.0 | No | Ramp | XSlope (%) | 3.0 | | |

| Possible Solutions: | <u> </u> |
|---|---|
| Remove & Replace Entire Ramp. | |
