# Access Compliance Report

## Public Rights-of-Way

### (Curb Ramps)

Intersection ID: 19257	Main Street: TRYON_ST	Cross Street: BEAM_RD	Location: SE
ADA ID: F72CB8FBEE0C	Ramp Type: Perp	Initial Pass/Fail: Fail	Overall Compliance: No
		Severity Score: 12.5

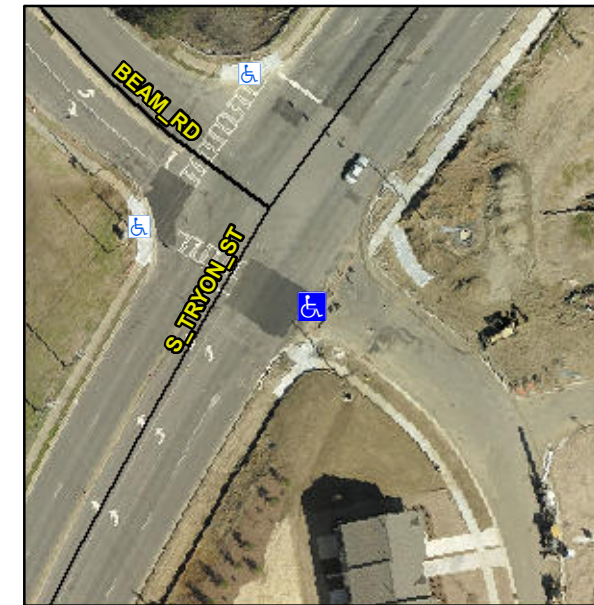
Compliance	Description	Data	Compliance	Description	Data
N/A	Ramp Length (in)	91.0	No	Ramp Slope (%)	9.9
Yes	Ramp Width (in)	48.0	Yes	Ramp XSlope (%)	2.0
N/A	Flare Type LT	N/A	N/A	Flare Type RT	N/A
N/A	Flare Slope LT (%)	N/A	N/A	Flare Slope RT (%)	N/A
N/A	Flare Traversable LT?	N/A	N/A	Flare Traversable RT?	N/A
N/A	Landing Length (in)	N/A	N/A	DWS Provided?	N/A
N/A	Landing Width (in)	N/A	N/A	DWS Contrast?	N/A
N/A	Landing Slope (%)	N/A	N/A	DWS Length (in)	N/A
N/A	Landing X Slope (%)	N/A	N/A	DWS Full Width?	N/A
N/A	Landing Curb? (Y/N)	N/A	N/A	DWS Offset (in)	N/A
N/A	Shared Landing?	N/A			
N/A	Gutter Ponding?	N/A	N/A	Gutter Slope (%)	N/A
N/A	Gutter Lip Ht (in)	N/A	N/A	Gutter X Slope (%)	N/A
N/A	Painted X Walk1?	Yes	N/A	Painted X Walk2?	N/A
	X Walk 1 Direction	To NW		X Walk 2 Direction	N/A
N/A	X Walk 1 Width (in)	110.0	N/A	X Walk 2 Width (in)	N/A
	X Walk 1 Slope (%)	4.5		X Walk 2 Slope (%)	N/A
	X Walk 1 X Slope (%)	2.7		X Walk 2 X Slope (%)	N/A

N/A	Ramp inside XWalk1?	Yes	N/A	Ramp inside XWalk2?	N/A
	Road Slope (%)	N/A	N/A	Clear Space?	N/A
	Road X Slope (%)	N/A	N/A	Clear Space to XWalk (in)	N/A
N/A	Any Obstructions?	N/A	N/A	Storm Grate/Utility Hazard?	N/A
	Obstruction Type			Storm Grate/Utility Type	
		N/A			N/A
			Yes	Surface Condition? (G/P)	Good

**Remove & Replace Entire Ramp.**

**R304.2.2**
