Access Compliance Report

Public Rights-of-Way

(Curb Ramps)

Intersection ID: 20411	Main Street: ARCHDALE_DR	Cross Street: DELCHESTER_DR	Location: W
ADA ID: F73948BABEAA	Ramp Type: PerpDiag	Initial Pass/Fail: Fail	Overall Compliance: No
Severity Score: 10			
Codes/Mitigation Info/Possible Solution		Field Measurements/Component Compliance

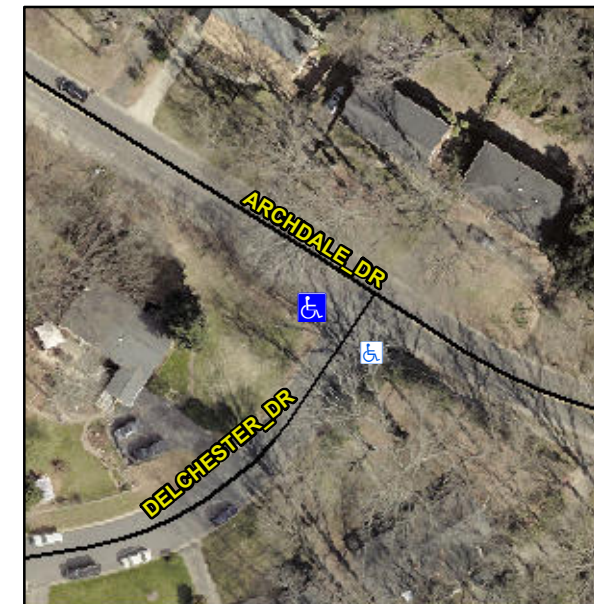
Not Found, R304.5.1, R304.5.3

Compliance	Description	Data	Compliance	Description	Data
N/A	Ramp Length (in)	59.0	Yes	Ramp Slope (%)	5.7
No	Ramp Width (in)	43.0	No	Ramp XSlope (%)	2.9
N/A	Flare Type LT	N/A	N/A	Flare Type RT	N/A
N/A	Flare Slope LT (%)	N/A	N/A	Flare Slope RT (%)	N/A
N/A	Flare Traversable LT?	N/A	N/A	Flare Traversable RT?	N/A
N/A	Landing Length (in)	N/A	N/A	DWS Provided?	N/A
N/A	Landing Width (in)	N/A	N/A	DWS Contrast?	N/A
N/A	Landing Slope (%)	N/A	N/A	DWS Length (in)	N/A
N/A	Landing X Slope (%)	N/A	N/A	DWS Full Width?	N/A
N/A	Landing Curb? (Y/N)	N/A	N/A	DWS Offset (in)	N/A
N/A	Shared Landing?	N/A			
N/A	Gutter Ponding?	N/A	N/A	Gutter Slope (%)	N/A
N/A	Gutter Lip Ht (in)	N/A	N/A	Gutter X Slope (%)	N/A
N/A	Painted X Walk1?	No	N/A	Painted X Walk2?	No
	X Walk 1 Direction	To SE		X Walk 2 Direction	To NE
N/A	X Walk 1 Width (in)	N/A	N/A	X Walk 2 Width (in)	N/A
	X Walk 1 Slope (%)	5.7		X Walk 2 Slope (%)	1.4
	X Walk 1 X Slope (%)	0.2		X Walk 2 X Slope (%)	2.8

N/A	Ramp inside XWalk1?	N/A	N/A	Ramp inside XWalk2?	N/A
	Road Slope (%)	2.9	N/A	Clear Space?	N/A
	Road X Slope (%)	3.6	N/A	Clear Space to XWalk (in)	N/A
N/A	Any Obstructions?	N/A	N/A	Storm Grate/Utility Hazard?	N/A
	Obstruction Type			Storm Grate/Utility Type	
		N/A			N/A
			Yes	Surface Condition? (G/P)	Good

Remove & Replace Curb Ramp With Two New Directional Ramps or Equivalent.
