# Access Compliance Report

## Public Rights-of-Way

### (Curb Ramps)

Intersection ID: 47659	Main Street: FENWAY_DR	Cross Street: WRIGLEY_DR	Location: NE
ADA ID: F7446F25032F	Ramp Type: Perp	Initial Pass/Fail: Fail	Overall Compliance: No
			Severity Score: 26.25

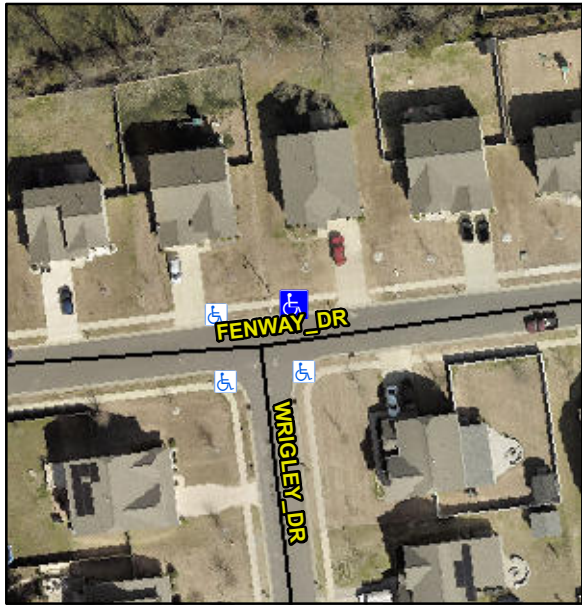
Possible Solutions:		Compliance	Description	Data	Compliance	Description	Data
	Remove & Replace Entire Ramp.		N/A	Ramp Length (in)	48.0	No	Ramp Slope (%)	12.1
			Yes	Ramp Width (in)	48.0	Yes	Ramp XSlope (%)	2.1
			N/A	Flare Type LT	N/A	N/A	Flare Type RT	N/A
			N/A	Flare Slope LT (%)	N/A	N/A	Flare Slope RT (%)	N/A
			N/A	Flare Traversable LT?	N/A	N/A	Flare Traversable RT?	N/A
			N/A	Landing Length (in)	N/A	N/A	DWS Provided?	N/A
			N/A	Landing Width (in)	N/A	N/A	DWS Contrast?	N/A
			N/A	Landing Slope (%)	N/A	N/A	DWS Length (in)	N/A
			N/A	Landing X Slope (%)	N/A	N/A	DWS Full Width?	N/A
Surveyor Notes:		N/A	N/A	Landing Curb? (Y/N)	N/A	N/A	DWS Offset (in)	N/A
PROW/ADA:		Not Found, R304.2.2	N/A	Shared Landing?	N/A			
			N/A	Gutter Ponding?	N/A	N/A	Gutter Slope (%)	N/A
			N/A	Gutter Lip Ht (in)	N/A	N/A	Gutter X Slope (%)	N/A

N/A	Painted X Walk1?	No	N/A	Painted X Walk2?	N/A
				X Walk 1 Direction	To S		X Walk 2 Direction	N/A
			N/A	X Walk 1 Width (in)	N/A	N/A	X Walk 2 Width (in)	N/A
				X Walk 1 Slope (%)	3.0		X Walk 2 Slope (%)	N/A
				X Walk 1 X Slope (%)	2.6		X Walk 2 X Slope (%)	N/A
			N/A	Ramp inside XWalk1?	N/A	N/A	Ramp inside XWalk2?	N/A
				Road Slope (%)	N/A	N/A	Clear Space?	N/A
				Road X Slope (%)	N/A	N/A	Clear Space to XWalk (in)	N/A
			N/A	Any Obstructions?	N/A	N/A	Storm Grate/Utility Hazard?	N/A
				Obstruction Type			Storm Grate/Utility Type	
					N/A			N/A
						Yes	Surface Condition? (G/P)	Good
