Access Compliance Report

Public Rights-of-Way

(Curb Ramps)

Intersection ID: 24153	Main Street: FRESHWELL_RD	Cross Street: STEPHENDALE_DR	Location: E
ADA ID: F744F0090E5E	Ramp Type: BlendTrans2	Initial Pass/Fail: Fail	Overall Compliance: No
Severity Score: 8.75			
Codes/Mitigation Info/Possible Solution		Field Measurements/Component Compliance

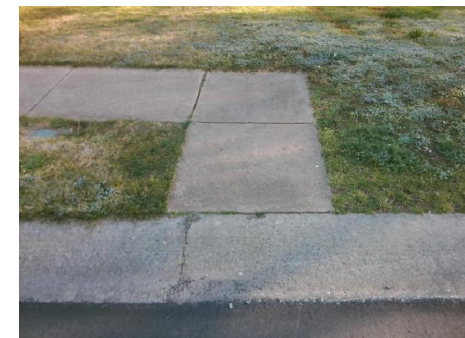
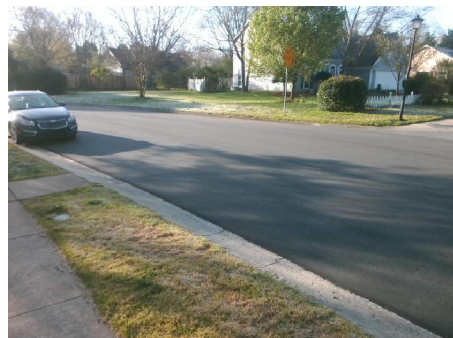
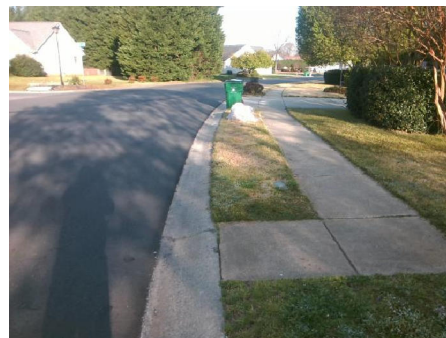
Not Found, R304.5.1

Compliance	Description	Data	Compliance	Description	Data
N/A	Ramp Length (in)	95.0	Yes	BlendTrans Slope (%)	1.3
No	Ramp Width (in)	46.5	Yes	BlendTrans XSlope (%)	0.3
N/A	Flare Type LT	N/A	N/A	Flare Type RT	N/A
N/A	Flare Slope LT (%)	N/A	N/A	Flare Slope RT (%)	N/A
N/A	Flare Traversable LT?	N/A	N/A	Flare Traversable RT?	N/A
N/A	Landing Length (in)	N/A	N/A	DWS Provided?	N/A
N/A	Landing Width (in)	N/A	N/A	DWS Contrast?	N/A
N/A	Landing Slope (%)	N/A	N/A	DWS Length (in)	N/A
N/A	Landing X Slope (%)	N/A	N/A	DWS Full Width?	N/A
N/A	Landing Curb? (Y/N)	N/A	N/A	DWS Offset (in)	N/A
N/A	Shared Landing?	N/A			
N/A	Gutter Ponding?	N/A	N/A	Gutter Slope (%)	N/A
N/A	Gutter Lip Ht (in)	N/A	N/A	Gutter X Slope (%)	N/A
N/A	Painted X Walk1?	No	N/A	Painted X Walk2?	N/A
	X Walk 1 Direction	To SW		X Walk 2 Direction	N/A
	X Walk 1 Width (in)	N/A		X Walk 2 Width (in)	N/A
	X Walk 1 Slope (%)	6.4		X Walk 2 Slope (%)	N/A
	X Walk 1 X Slope (%)	0.5		X Walk 2 X Slope (%)	N/A

N/A	Ramp inside XWalk1?	N/A	N/A	Ramp inside XWalk2?	N/A
	Road Slope (%)	0.5		Clear Space?	N/A
	Road X Slope (%)	6.4	N/A	Clear Space to XWalk (in)	N/A
N/A	Any Obstructions?	N/A	N/A	Storm Grate/Utility Hazard?	N/A
	Obstruction Type			Storm Grate/Utility Type	
		N/A			N/A
			Yes	Surface Condition? (G/P)	Good
			No	Curb Slope (%)	35.9

Remove & Replace Curb Ramp With Two New Directional Ramps or Equivalent.
