Access Compliance Report

Public Rights-of-Way

(Curb Ramps)

Intersection ID: 28193	Main Street: MARVIN_RD	Cross Street: JOHNSTON_RD	Location: SE
ADA ID: F74EBA4830EA	Ramp Type: BlendTrans2	Initial Pass/Fail: Fail	Overall Compliance: No
Severity Score: 33.75			
Codes/Mitigation Info/Possible Solution		Field Measurements/Component Compliance

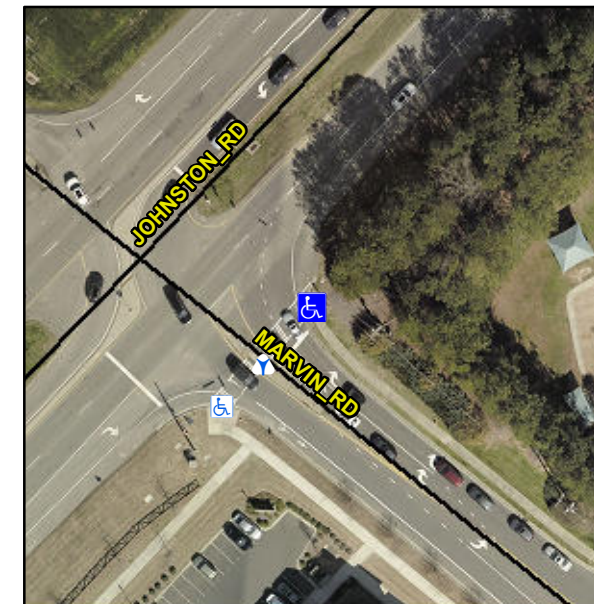
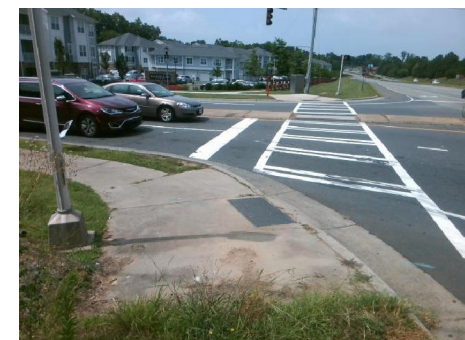
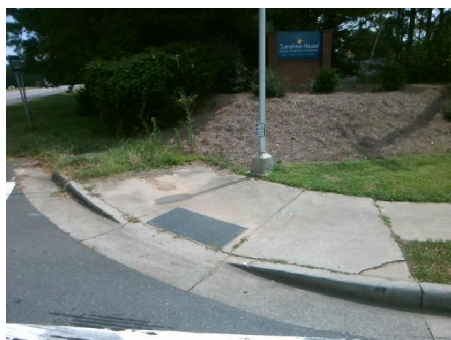
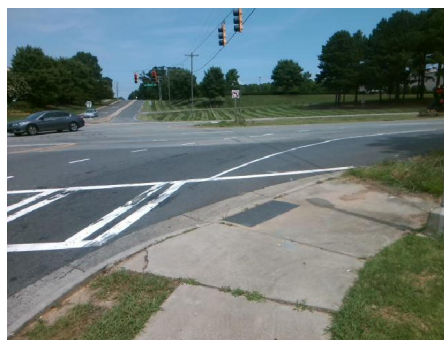
Not Found, R304.5.1, R304.5.3

Compliance	Description	Data	Compliance	Description	Data
N/A	Ramp Length (in)	96.0	Yes	BlendTrans Slope (%)	3.6
No	Ramp Width (in)	47.0	No	BlendTrans XSlope (%)	9.0
N/A	Flare Type LT	N/A	N/A	Flare Type RT	N/A
N/A	Flare Slope LT (%)	N/A	N/A	Flare Slope RT (%)	N/A
N/A	Flare Traversable LT?	N/A	N/A	Flare Traversable RT?	N/A
N/A	Landing Length (in)	N/A	N/A	DWS Provided?	N/A
N/A	Landing Width (in)	N/A	N/A	DWS Contrast?	N/A
N/A	Landing Slope (%)	N/A	N/A	DWS Length (in)	N/A
N/A	Landing X Slope (%)	N/A	N/A	DWS Full Width?	N/A
N/A	Landing Curb? (Y/N)	N/A	N/A	DWS Offset (in)	N/A
N/A	Shared Landing?	N/A			
N/A	Gutter Ponding?	N/A	N/A	Gutter Slope (%)	N/A
N/A	Gutter Lip Ht (in)	N/A	N/A	Gutter X Slope (%)	N/A
N/A	Painted X Walk1?	Yes	N/A	Painted X Walk2?	N/A
	X Walk 1 Direction	To SW		X Walk 2 Direction	N/A
	X Walk 1 Width (in)	108.0		X Walk 2 Width (in)	N/A
	X Walk 1 Slope (%)	1.5		X Walk 2 Slope (%)	N/A
	X Walk 1 X Slope (%)	2.0		X Walk 2 X Slope (%)	N/A

N/A	Ramp inside XWalk1?	Yes	N/A	Ramp inside XWalk2?	N/A
	Road Slope (%)	2.0		Clear Space?	N/A
	Road X Slope (%)	1.5	N/A	Clear Space to XWalk (in)	N/A
N/A	Any Obstructions?	N/A	N/A	Storm Grate/Utility Hazard?	N/A
	Obstruction Type			Storm Grate/Utility Type	
		N/A			N/A
			Yes	Surface Condition? (G/P)	Good
			No	Curb Slope (%)	17.1

Possible Solutions:

Remove & Replace Curb Ramp With Two New Directional Ramps or Equivalent.
