## Access Compliance Report Public Rights-of-Way (Curb Ramps)

Intersection ID: 46184 Main Street: GLOXINIA\_RD Cross Street: NEEDLEPOINT\_RD Location: S

ADA ID: F7503738FE52 Ramp Type: BlendTrans1 Initial Pass/Fail: Fail Overall Compliance: No Severity Score: 8.75

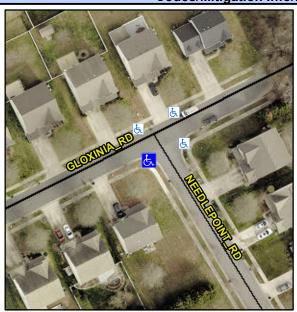
Not Found, R304.5.1

i icia incusui cincitto/osimponent osimphanoe						
	Compliance Description		Data	Compliance Description		Data
	N/A	Ramp Length (in)	61.0	Yes	BlendTrans Slope (%)	4.6
	No	Ramp Width (in)	47.5	Yes	BlendTrans XSlope (%)	0.4
	N/A	Flare Type LT	N/A	N/A	Flare Type RT	N/A
	N/A	Flare Slope LT (%)	N/A	N/A	Flare Slope RT (%)	N/A
	N/A	Flare Traversable LT?	N/A	N/A	Flare Traversable RT?	N/A
	N/A	Landing Length (in)	N/A	N/A	DWS Provided?	N/A
	N/A	Landing Width (in)	N/A	N/A	DWS Contrast?	N/A
	N/A	Landing Slope (%)	N/A	N/A	DWS Length (in)	N/A
	N/A	Landing X Slope (%)	N/A	N/A	DWS Full Width?	N/A
	N/A	Landing Curb? (Y/N)	N/A	N/A	DWS Offset (in)	N/A
	N/A	Shared Landing?	N/A			
	N/A	Gutter Ponding?	N/A	N/A	Gutter Slope (%)	N/A
	N/A	Gutter Lip Ht (in)	0.5	N/A	Gutter X Slope (%)	N/A
	N/A	Painted X Walk1?	No	N/A	Painted X Walk2?	No
		X Walk 1 Direction	To NE		X Walk 2 Direction	To NW
		X Walk 1 Width (in)	N/A		X Walk 2 Width (in)	N/A

X Walk 1 Slope (%)	1.7		X Walk 2 Slope (%)	2.0
		X Walk 1 X Slope (%)	0.0		X Walk 2 X Slope (%)	0.8
	N/A	Ramp inside XWalk1?	N/A	N/A	Ramp inside XWalk2?	N/A
		Road Slope (%)	0.7		Clear Space?	N/A
		Road X Slope (%)	0.6	N/A	Clear Space to XWalk (in)	N/A
	N/A	Any Obstructions?	N/A	N/A	Storm Grate/Utility Hazard?	N/A
		Obstruction Type			Storm Grate/Utility Type	
			N/A			N/A

Remove & Replace Curb Ramp With Two New Directional Ramps or Equivalent.
