Access Compliance Report

Public Rights-of-Way

(Curb Ramps)

Intersection ID: N/A	Main Street: HALKIRK_MANOR_LN	Cross Street: KIRKWYND_COMMONS_DR	Location: SW
ADA ID: F753ADE08A02	Ramp Type: PerpDiag	Initial Pass/Fail: Fail	Overall Compliance: No
Severity Score: 13.75			
Codes/Mitigation Info/Possible Solution		Field Measurements/Component Compliance

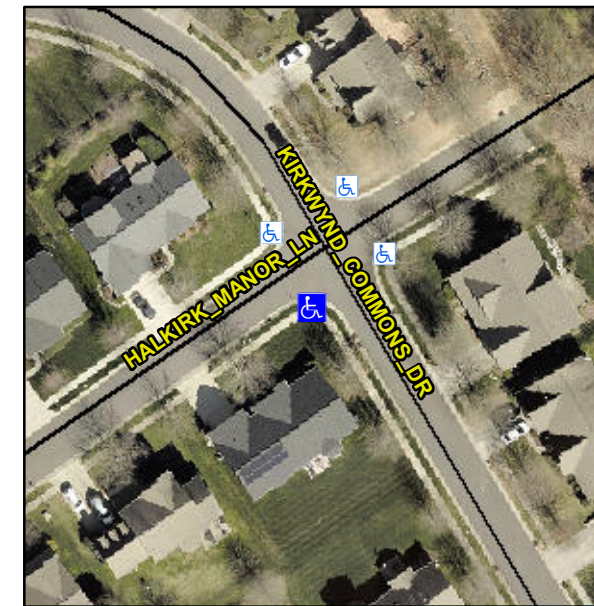
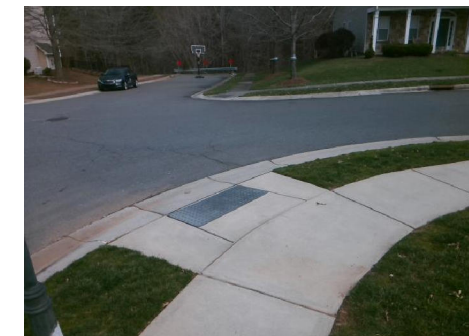
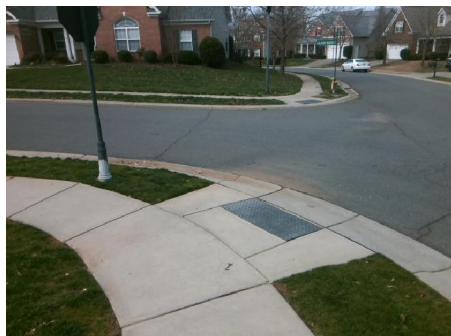
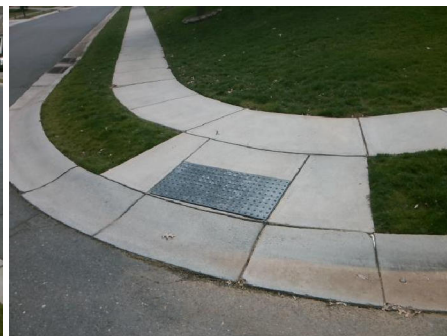
Not Found, R304.2.2, R304.5.3

Compliance	Description	Data	Compliance	Description	Data
N/A	Ramp Length (in)	46.0	No	Ramp Slope (%)	9.3
Yes	Ramp Width (in)	48.0	No	Ramp XSlope (%)	3.2
N/A	Flare Type LT	N/A	N/A	Flare Type RT	N/A
N/A	Flare Slope LT (%)	N/A	N/A	Flare Slope RT (%)	N/A
N/A	Flare Traversable LT?	N/A	N/A	Flare Traversable RT?	N/A
N/A	Landing Length (in)	N/A	N/A	DWS Provided?	N/A
N/A	Landing Width (in)	N/A	N/A	DWS Contrast?	N/A
N/A	Landing Slope (%)	N/A	N/A	DWS Length (in)	N/A
N/A	Landing X Slope (%)	N/A	N/A	DWS Full Width?	N/A
N/A	Landing Curb? (Y/N)	N/A	N/A	DWS Offset (in)	N/A
N/A	Shared Landing?	N/A			
N/A	Gutter Ponding?	N/A	N/A	Gutter Slope (%)	N/A
N/A	Gutter Lip Ht (in)	N/A	N/A	Gutter X Slope (%)	N/A
N/A	Painted X Walk1?	No	N/A	Painted X Walk2?	No
	X Walk 1 Direction	To NE		X Walk 2 Direction	To NW
N/A	X Walk 1 Width (in)	N/A	N/A	X Walk 2 Width (in)	N/A
	X Walk 1 Slope (%)	0.8		X Walk 2 Slope (%)	1.0
	X Walk 1 X Slope (%)	2.2		X Walk 2 X Slope (%)	2.1

N/A	Ramp inside XWalk1?	N/A	N/A	Ramp inside XWalk2?	N/A
	Road Slope (%)	0.8	N/A	Clear Space?	N/A
	Road X Slope (%)	1.0	N/A	Clear Space to XWalk (in)	N/A
N/A	Any Obstructions?	N/A	N/A	Storm Grate/Utility Hazard?	N/A
	Obstruction Type			Storm Grate/Utility Type	
		N/A			N/A
			Yes	Surface Condition? (G/P)	Good

Remove & Replace Curb Ramp With Two New Directional Ramps or Equivalent.
