Access Compliance Report

Public Rights-of-Way

(Curb Ramps)

Intersection ID: 28245	Main Street: SOCIETY_ST	Cross Street: COMMUNITY_HOUSE_RD	Location: NE
ADA ID: F7588941E662	Ramp Type: Perp	Initial Pass/Fail: Fail	Overall Compliance: No
Severity Score: 13.75			
Codes/Mitigation Info/Possible Solution		Field Measurements/Component Compliance

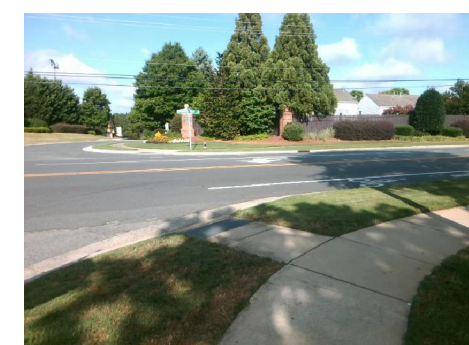
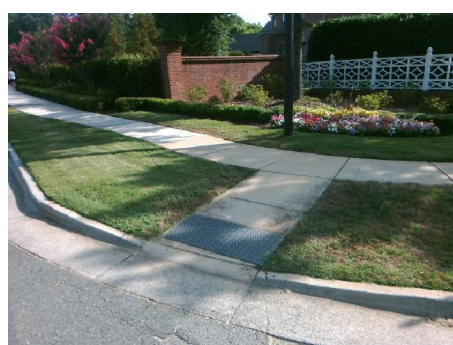
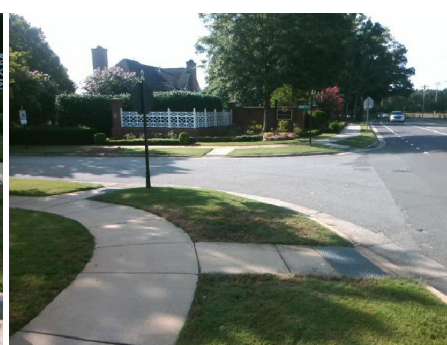
Compliance	Description	Data	Compliance	Description	Data
N/A	Ramp Length (in)	97.0	No	Ramp Slope (%)	8.5
Yes	Ramp Width (in)	48.0	No	Ramp XSlope (%)	4.6
N/A	Flare Type LT	N/A	N/A	Flare Type RT	N/A
N/A	Flare Slope LT (%)	N/A	N/A	Flare Slope RT (%)	N/A
N/A	Flare Traversable LT?	N/A	N/A	Flare Traversable RT?	N/A
N/A	Landing Length (in)	N/A	N/A	DWS Provided?	N/A
N/A	Landing Width (in)	N/A	N/A	DWS Contrast?	N/A
N/A	Landing Slope (%)	N/A	N/A	DWS Length (in)	N/A
N/A	Landing X Slope (%)	N/A	N/A	DWS Full Width?	N/A
N/A	Landing Curb? (Y/N)	N/A	N/A	DWS Offset (in)	N/A
N/A	Shared Landing?	N/A			
N/A	Gutter Ponding?	N/A	N/A	Gutter Slope (%)	N/A
N/A	Gutter Lip Ht (in)	N/A	N/A	Gutter X Slope (%)	N/A
N/A	Painted X Walk1?	No	N/A	Painted X Walk2?	N/A
	X Walk 1 Direction	To SW		X Walk 2 Direction	N/A
N/A	X Walk 1 Width (in)	N/A	N/A	X Walk 2 Width (in)	N/A
	X Walk 1 Slope (%)	7.9		X Walk 2 Slope (%)	N/A
	X Walk 1 X Slope (%)	3.3		X Walk 2 X Slope (%)	N/A

N/A	Ramp inside XWalk1?	N/A	N/A	Ramp inside XWalk2?	N/A
	Road Slope (%)	N/A	N/A	Clear Space?	N/A
	Road X Slope (%)	N/A	N/A	Clear Space to XWalk (in)	N/A
N/A	Any Obstructions?	N/A	N/A	Storm Grate/Utility Hazard?	N/A
	Obstruction Type			Storm Grate/Utility Type	
		N/A			N/A
			Yes	Surface Condition? (G/P)	Good

Remove & Replace Entire Ramp.
