## Access Compliance Report Public Rights-of-Way (Curb Ramps)

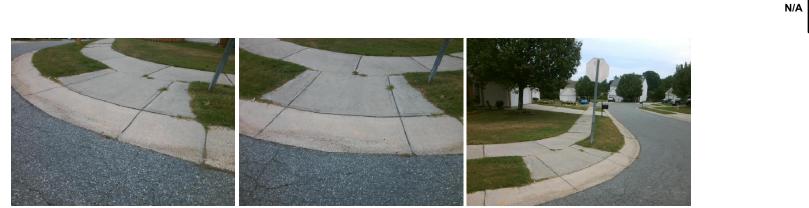
`````````````````````````````````									
Intersection ID: 30287	Main Street: CHALLENGER_DR (			treet:	GREYLOCK_CT	Location:	N		
ADA ID: F764E3B551A9	Ramp Ty	Ramp Type: PerpDiag In			ail: Pass Overal	o Severity Score:	10.25		
Codes/Mitigation Info/Possible Solution				Field Measurements/Component Compliance					
		Possible Solutions:		Compliance Description		Data Compliance Description			Data
Nº NO		Remove & Replace Curb Ramp W	lith	N/A	Ramp Length (in)	48.5	Yes	Ramp Slope (%)	5.7
		Two New Directional Ramps or		Yes	Ramp Width (in)	48.0	No	Ramp XSlope (%)	4.0
		Equivalent. Remove & Replace Gutter.		N/A	Flare Type LT	Sloped	N/A	Flare Type RT	N/A
production and				N/A	Flare Slope LT (%)	-	N/A	Flare Slope RT (%)	3.1
				N/A	Flare Traversable LT?	No	N/A	Flare Traversable RT?	No
				Yes	Landing Length (in)	48.0		DWS Provided?	No

- Andrew P	Surveyor Notes:		Yes	Landing Width (in)		N/A	DWS Contrast?	No
Chan E	to the	N/A		No	Landing Slope (%)		N/A	DWS Length (in)	N/A
NEW CONTRACTOR		N/6		No	Landing X Slope (%)		N/A	DWS Full Width?	No
17 28 1	ROR			N/A	Landing Curb? (Y/N)		N/A	DWS Offset (in)	N/A
		PROW/ADA: Not Found, R304.5.3, R304.2.2-Per R304.3.2-Para, R305		N/A	Shared Landing?	No		Bitte enter(iii)	1007
	1 million			Yes	Gutter Ponding?	No		Gutter Slope (%)	0.5
alles with the little	7 M. Mar		Perp,	Yes	Gutter Lip Ht (in)	0.0		Gutter X Slope (%)	6.1
Marine Marine Marine	The is			N/A	Painted X Walk1?		N/A	Painted X Walk2?	No
the second second	HE VALS			N/A			N/A		-
A CONTRACTOR OF A CONTRACTOR					X Walk 1 Direction	To SW		X Walk 2 Direction	To SE
		1		N/A	X Walk 1 Width (in)		N/A	X Walk 2 Width (in)	N/A
Street 1 Name	CHALLENGER DR				X Walk 1 Slope (%)	8.9		X Walk 2 Slope (%)	4.2
Stop Condition-Street 2	None				X Walk 1 X Slope (%)	1.3		X Walk 2 X Slope (%)	5.9

Street 2 Name	GREYLOCK CT			N/A	Ramp inside XWalk1?		N/A	Ramp inside XWalk2?	N/A
Stop Condition-Street 1	StopSign				Road Slope (%)	7.3		Clear Space?	Yes
					Road X Slope (%)	6.5	N/A	Clear Space to XWalk (in)	N/A
				Yes	Any Obstructions?	No	Yes	Storm Grate/Utility Hazard?	No
		Total Cost: \$ 39	950.00		Obstruction Type			Storm Grate/Utility Type	
						N/A			N/A
4

Yes Surface Condition? (G/P)

Good
