# Access Compliance Report

## Public Rights-of-Way

### (Curb Ramps)

Intersection ID: N/A	Main Street: SIKES_PL	Cross Street: N/A	Location: NE
ADA ID: F76551AA5D97	Ramp Type: Perp	Initial Pass/Fail: Fail	Overall Compliance: No
Severity Score: 21.25			
Codes/Mitigation Info/Possible Solution		Field Measurements/Component Compliance

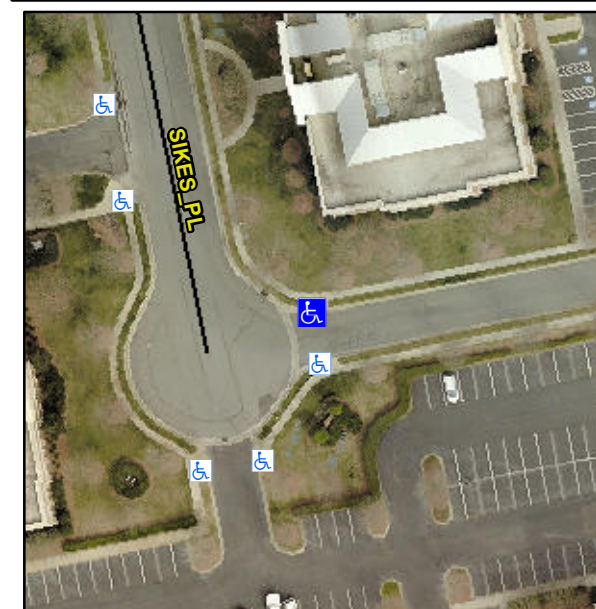
**R304.5.1, R304.2.2**

Compliance	Description	Data	Compliance	Description	Data
N/A	Ramp Length (in)	52.0	No	Ramp Slope (%)	10.3
No	Ramp Width (in)	44.5	Yes	Ramp XSlope (%)	1.0
N/A	Flare Type LT	N/A	N/A	Flare Type RT	N/A
N/A	Flare Slope LT (%)	N/A	N/A	Flare Slope RT (%)	N/A
N/A	Flare Traversable LT?	N/A	N/A	Flare Traversable RT?	N/A
N/A	Landing Length (in)	N/A	N/A	DWS Provided?	N/A
N/A	Landing Width (in)	N/A	N/A	DWS Contrast?	N/A
N/A	Landing Slope (%)	N/A	N/A	DWS Length (in)	N/A
N/A	Landing X Slope (%)	N/A	N/A	DWS Full Width?	N/A
N/A	Landing Curb? (Y/N)	N/A	N/A	DWS Offset (in)	N/A
N/A	Shared Landing?	N/A			
N/A	Gutter Ponding?	N/A	N/A	Gutter Slope (%)	N/A
N/A	Gutter Lip Ht (in)	N/A	N/A	Gutter X Slope (%)	N/A
N/A	Painted X Walk1?	No	N/A	Painted X Walk2?	N/A
	X Walk 1 Direction	To S		X Walk 2 Direction	N/A
N/A	X Walk 1 Width (in)	N/A	N/A	X Walk 2 Width (in)	N/A
	X Walk 1 Slope (%)	1.1		X Walk 2 Slope (%)	N/A
	X Walk 1 X Slope (%)	0.6		X Walk 2 X Slope (%)	N/A

N/A	Ramp inside XWalk1?	N/A	N/A	Ramp inside XWalk2?	N/A
	Road Slope (%)	N/A	N/A	Clear Space?	N/A
	Road X Slope (%)	N/A	N/A	Clear Space to XWalk (in)	N/A
N/A	Any Obstructions?	N/A	N/A	Storm Grate/Utility Hazard?	N/A
	Obstruction Type			Storm Grate/Utility Type	
		N/A			N/A
		Yes		Surface Condition? (G/P)	Good

Possible Solutions:

**Remove & Replace Entire Ramp.**
