## **Access Compliance Report Public Rights-of-Way** (Curb Ramps)

Intersection ID: 52453 Main Street: PAT GARRETT ST Cross Street: DOUBLE OAKS RD Location: SW **ADA ID: F7886EDC3F6E** Ramp Type: Perp Initial Pass/Fail: Fail **Overall Compliance: No Severity Score:** 12.5

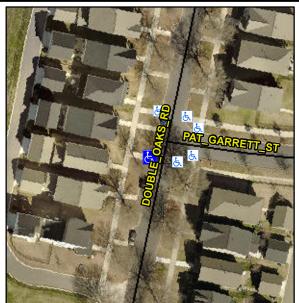
66.0 Yes

86.0 No

Ramp Slope (%)

Ramp XSlope (%)

P. L. C.	E E	N/A		N/A	Landing Slope (%)	N/A	N/A	DWS Length (in)	N/A
				N/A	Landing X Slope (%)	N/A	N/A	DWS Full Width?	N/A
8				N/A	Landing Curb? (Y/N)	N/A	N/A	DWS Offset (in)	N/A
		4		N/A	Shared Landing?	N/A			
		PROW/ADA:		N/A	Gutter Ponding?	N/A	N/A	Gutter Slope (%)	N/A
		Not Found, R304.2.2		N/A	Gutter Lip Ht (in)	2.0	N/A	Gutter X Slope (%)	N/A
	1			N/A	Painted X Walk1?	No	N/A	Painted X Walk2?	N/A
					X Walk 1 Direction	To E		X Walk 2 Direction	N/A
A NAME OF THE OWNER OWNER OF THE OWNER O				N/A	X Walk 1 Width (in)	N/A	N/A	X Walk 2 Width (in)	N/A
Street 1 Name	DOUBLE OAKS RD	_			X Walk 1 Slope (%)	3.3		X Walk 2 Slope (%)	N/A
Stop Condition-Street 2	None				X Walk 1 X Slope (%)	1.0		X Walk 2 X Slope (%)	N/A
Street 2 Name	N/A			N/A	Ramp inside XWalk1?	N/A	N/A	Ramp inside XWalk2?	N/A
Stop Condition-Street 1	N/A				Road Slope (%)	N/A	N/A	Clear Space?	N/A
					Road X Slope (%)	N/A	N/A	Clear Space to XWalk (in)	N/A

Possible Solutions:	Compli	iance	Description	
Remove & Replace Entire Ramp.	N/A	N/A Ramp Length (in) Yes Ramp Width (in) N/A Flare Type LT N/A Flare Slope LT (%)		
·	Yes			
	N/A			
	N/A			
	N/A	Flare Traversable L		
	N/A	Land	ing Length (in)	
Surveyor Notes:	N/A	Land	ing Width (in)	
N/A	N/A	Land	ing Slope (%)	
	N/A	Land	ing X Slope (%)	
	N/A	Land	ing Curb? (Y/N)	
	N/A	Shar	ed Landing?	
PROW/ADA:	N/A	Gutte	er Ponding?	
Not Found, R304.2.2	N/A	Gutte	er Lip Ht (in)	
	N/A	Paint	ed X Walk1?	
		X Wa	lk 1 Direction	
	N/A	X Wa	lk 1 Width (in)	
		X Wa	lk 1 Slope (%)	
		X Wa	lk 1 X Slope (%	
	N/A	Ram	o inside XWalk1
