Access Compliance Report

Public Rights-of-Way (Curb Ramps)

Intersection ID: 24700	Main Street: HARLEQUIN_DR	Cross Street: WHISTLING_DUCK_CT	Location: SE
ADA ID: F78BDA23B497	Ramp Type: Directional1	Initial Pass/Fail: Fail	Overall Compliance: No
			Severity Score: 21.25

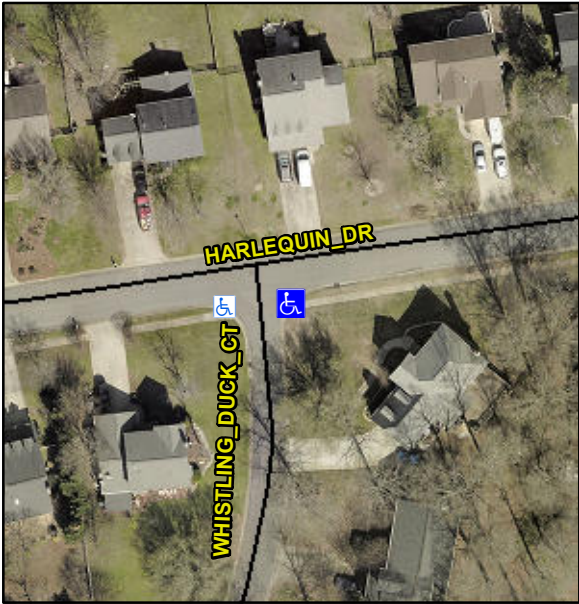
Possible Solutions:		Compliance			Description			Data	
	Remove & Replace Entire Ramp.		N/A	Ramp Length (in)	53.0	N/A	Grade Break?	N/A		
			No	Ramp Width (in)	44.0	N/A	Grade Break Slope (%)	0.0		
			Yes	Ramp Slope (%)	3.3	N/A	Grade Break XSlope (%)	0.0		
			No	Ramp XSlope (%)	6.7					
			N/A	Flare Type LT	N/A	N/A	Flare Type RT	N/A		
			N/A	Flare Slope LT (%)	N/A	N/A	Flare Slope RT (%)	0.0		
			N/A	Flare Traversable LT?	N/A	N/A	Flare Traversable RT?	N/A		
			N/A	Landing Length (in)	0.0	N/A	DWS Provided?	N/A		
			N/A	Landing Width (in)	0.0	N/A	DWS Contrast?	N/A		
Surveyor Notes:		N/A			N/A			Landing Slope (%)	0.0	N/A
PROW/ADA:		R304.5.1, R304.5.3			N/A			Landing X Slope (%)	0.0	N/A
					N/A			Landing Curb? (Y/N)	N/A	N/A
					N/A			Shared Landing?	N/A	N/A
					N/A			Gutter Ponding?	0.0	N/A
					N/A			Gutter Lip Ht (in)	0.0	N/A

N/A			Painted X Walk1?	No	N/A
					To SW			Road Slope (%)	2.2	N/A
					N/A			Road X Slope (%)	0.5	N/A
					N/A			Clear Space?	N/A	N/A
					N/A			Clear Space to XWalk (in)	N/A	N/A
					N/A			Storm Grate/Utility Hazard?	N/A	N/A
					N/A			Storm Grate/Utility Type		N/A
					N/A					N/A
					Yes			Surface Condition? (G/P)	Good	
					N/A			Curb Slope (%)	8.1
