# Access Compliance Report

## Public Rights-of-Way

### (Curb Ramps)

Intersection ID: 6154	Main Street: GORDON_WALTERS_DR	Cross Street: PERNELL_LN	Location: SE
ADA ID: F795CEF26841	Ramp Type: Perp	Initial Pass/Fail: Fail	Overall Compliance: No
Severity Score: 12.5			
Codes/Mitigation Info/Possible Solution		Field Measurements/Component Compliance

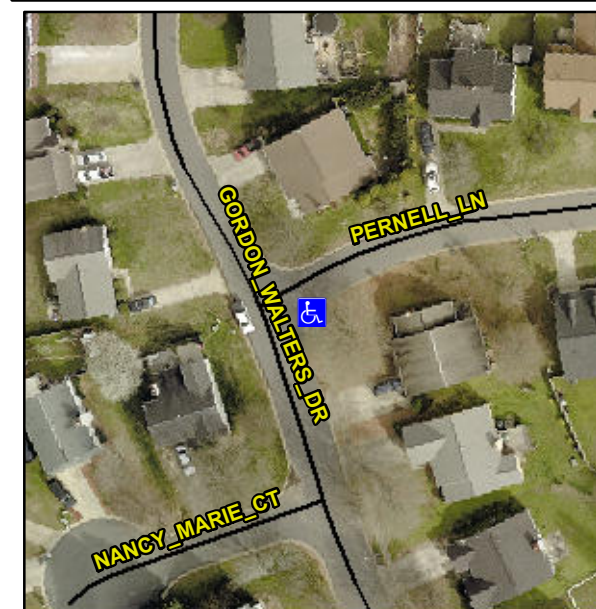
Compliance	Description	Data	Compliance	Description	Data
N/A	Ramp Length (in)	38.5	No	Ramp Slope (%)	8.6
Yes	Ramp Width (in)	48.0	Yes	Ramp XSlope (%)	1.1
N/A	Flare Type LT	N/A	N/A	Flare Type RT	N/A
N/A	Flare Slope LT (%)	N/A	N/A	Flare Slope RT (%)	N/A
N/A	Flare Traversable LT?	N/A	N/A	Flare Traversable RT?	N/A
N/A	Landing Length (in)	N/A	N/A	DWS Provided?	N/A
N/A	Landing Width (in)	N/A	N/A	DWS Contrast?	N/A
N/A	Landing Slope (%)	N/A	N/A	DWS Length (in)	N/A
N/A	Landing X Slope (%)	N/A	N/A	DWS Full Width?	N/A
N/A	Landing Curb? (Y/N)	N/A	N/A	DWS Offset (in)	N/A
N/A	Shared Landing?	N/A			
N/A	Gutter Ponding?	N/A	N/A	Gutter Slope (%)	N/A
N/A	Gutter Lip Ht (in)	N/A	N/A	Gutter X Slope (%)	N/A
N/A	Painted X Walk1?	No	N/A	Painted X Walk2?	N/A
	X Walk 1 Direction	To N		X Walk 2 Direction	N/A
N/A	X Walk 1 Width (in)	N/A	N/A	X Walk 2 Width (in)	N/A
	X Walk 1 Slope (%)	3.5		X Walk 2 Slope (%)	N/A
	X Walk 1 X Slope (%)	2.5		X Walk 2 X Slope (%)	N/A

N/A	Ramp inside XWalk1?	N/A	N/A	Ramp inside XWalk2?	N/A
	Road Slope (%)	N/A	N/A	Clear Space?	N/A
	Road X Slope (%)	N/A	N/A	Clear Space to XWalk (in)	N/A
N/A	Any Obstructions?	N/A	N/A	Storm Grate/Utility Hazard?	N/A
	Obstruction Type			Storm Grate/Utility Type	
		N/A			N/A
			Yes	Surface Condition? (G/P)	Good

Possible Solutions:

**Remove & Replace Entire Ramp.**

**R304.2.2**
