Access Compliance Report

Public Rights-of-Way

(Curb Ramps)

Intersection ID: 14085	Main Street: CARLTON_AV	Cross Street: MT_VERNON_AV	Location: SW
ADA ID: F79CEF5639EB	Ramp Type: Perp	Initial Pass/Fail: Fail	Overall Compliance: No
Severity Score: 42.5			
Codes/Mitigation Info/Possible Solution		Field Measurements/Component Compliance

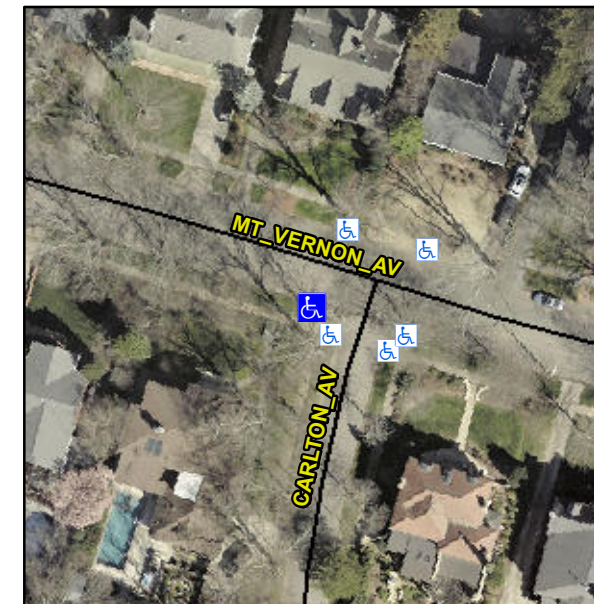
Not Found, R304.5.1, R304.2.2, R304.5.3

Compliance	Description	Data	Compliance	Description	Data
N/A	Ramp Length (in)	38.0	No	Ramp Slope (%)	10.0
No	Ramp Width (in)	35.0	No	Ramp XSlope (%)	5.5
N/A	Flare Type LT	N/A	N/A	Flare Type RT	N/A
N/A	Flare Slope LT (%)	N/A	N/A	Flare Slope RT (%)	N/A
N/A	Flare Traversable LT?	N/A	N/A	Flare Traversable RT?	N/A
N/A	Landing Length (in)	N/A	N/A	DWS Provided?	N/A
N/A	Landing Width (in)	N/A	N/A	DWS Contrast?	N/A
N/A	Landing Slope (%)	N/A	N/A	DWS Length (in)	N/A
N/A	Landing X Slope (%)	N/A	N/A	DWS Full Width?	N/A
N/A	Landing Curb? (Y/N)	N/A	N/A	DWS Offset (in)	N/A
N/A	Shared Landing?	N/A			
N/A	Gutter Ponding?	Yes	N/A	Gutter Slope (%)	N/A
N/A	Gutter Lip Ht (in)	N/A	N/A	Gutter X Slope (%)	N/A
N/A	Painted X Walk1?	No	N/A	Painted X Walk2?	N/A
	X Walk 1 Direction	To NE		X Walk 2 Direction	N/A
N/A	X Walk 1 Width (in)	N/A	N/A	X Walk 2 Width (in)	N/A
	X Walk 1 Slope (%)	3.7		X Walk 2 Slope (%)	N/A
	X Walk 1 X Slope (%)	0.5		X Walk 2 X Slope (%)	N/A

N/A	Ramp inside XWalk1?	N/A	N/A	Ramp inside XWalk2?	N/A
	Road Slope (%)	N/A	N/A	Clear Space?	N/A
	Road X Slope (%)	N/A	N/A	Clear Space to XWalk (in)	N/A
N/A	Any Obstructions?	N/A	N/A	Storm Grate/Utility Hazard?	N/A
	Obstruction Type			Storm Grate/Utility Type	
		N/A			N/A
		Yes		Surface Condition? (G/P)	Good

Remove & Replace Entire Ramp.
