## **Access Compliance Report Public Rights-of-Way** (Curb Ramps)

Intersection ID: 30366 Main Street: EASTWYCKE PLACE DR **Cross Street: SUBIRA LN** Location: SW Initial Pass/Fail: Fail **Overall Compliance: No Severity Score: ADA ID: F79FE0EE1259** Ramp Type: PerpDiag 8.75

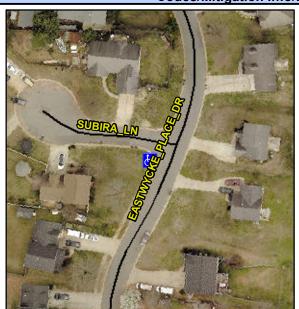
Compliance Description Data Compliance Description Data Yes Ramp Length (in) 83.0 Ramp Slope (%) 6.2 Yes Ramp XSlope (%) Ramp Width (in) 39.0 0.1 N/A Flare Type LT N/A Flare Type RT N/A N/A N/A Flare Slope RT (%) N/A Flare Slope LT (%) Flare Traversable LT? N/A N/A Flare Traversable RT? N/A N/A N/A **DWS Provided?** N/A Landing Length (in) Landing Width (in) N/A N/A **DWS Contrast?** N/A N/A N/A Landing Slope (%) DWS Length (in) N/A Landing X Slope (%) N/A N/A DWS Full Width? N/A Landing Curb? (Y/N) N/A N/A DWS Offset (in) N/A N/A Shared Landing? **Gutter Ponding?** N/A N/A Gutter Slope (%) N/A Gutter Lip Ht (in) N/A N/A Gutter X Slope (%) N/A Painted X Walk1? No N/A Painted X Walk2? No X Walk 1 Direction To E X Walk 2 Direction To N N/A X Walk 2 Width (in) X Walk 1 Width (in) N/A X Walk 1 Slope (%) N/A X Walk 2 Slope (%) N/A X Walk 1 X Slope (%) N/A X Walk 2 X Slope (%) N/A N/A N/A Ramp inside XWalk2? Ramp inside XWalk1? N/A Road Slope (%) N/A N/A Clear Space? N/A N/A Road X Slope (%) N/A Clear Space to XWalk (in) N/A N/A Any Obstructions? N/A Storm Grate/Utility Hazard? N/A **Obstruction Type** Storm Grate/Utility Type N/A N/A Yes Surface Condition? (G/P) Good

Possible Solutions: Remove & Replace Curb Ramp With Two New Directional Ramps or Equivalent. Surveyor Notes: N/A PROW/ADA: R304.5.1
