Access Compliance Report

Public Rights-of-Way (Curb Ramps)

Intersection ID: 10038573	Main Street: SPRINGMAN_LN	Cross Street: N/A	Location:	E
ADA ID: F7A029DA767E	Ramp Type: BlendTrans1	Initial Pass/Fail: Fail	Overall Compliance: No	Severity Score: 10

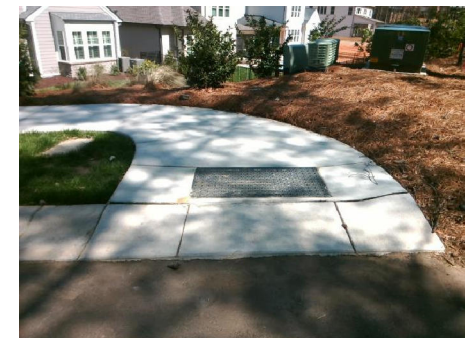
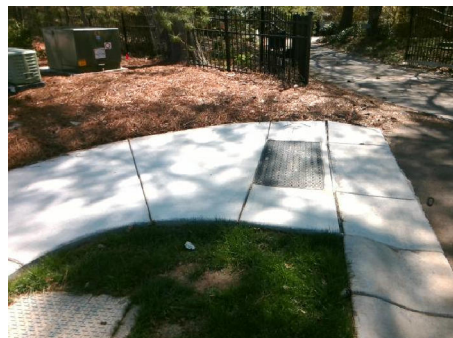
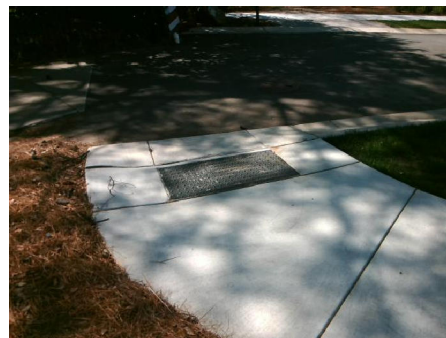
Not Found, R304.5.1

Compliance	Description	Data	Compliance	Description	Data
N/A	Ramp Length (in)	27.5	Yes	BlendTrans Slope (%)	2.7
No	Ramp Width (in)	47.0	Yes	BlendTrans XSlope (%)	3.9
N/A	Flare Type LT	N/A	N/A	Flare Type RT	N/A
N/A	Flare Slope LT (%)	N/A	N/A	Flare Slope RT (%)	N/A
N/A	Flare Traversable LT?	N/A	N/A	Flare Traversable RT?	N/A
N/A	Landing Length (in)	N/A	N/A	DWS Provided?	N/A
N/A	Landing Width (in)	N/A	N/A	DWS Contrast?	N/A
N/A	Landing Slope (%)	N/A	N/A	DWS Length (in)	N/A
N/A	Landing X Slope (%)	N/A	N/A	DWS Full Width?	N/A
N/A	Landing Curb? (Y/N)	N/A	N/A	DWS Offset (in)	N/A
N/A	Shared Landing?	N/A			
N/A	Gutter Ponding?	N/A	N/A	Gutter Slope (%)	N/A
N/A	Gutter Lip Ht (in)	N/A	N/A	Gutter X Slope (%)	N/A
N/A	Painted X Walk1?	No	N/A	Painted X Walk2?	N/A
	X Walk 1 Direction	To W		X Walk 2 Direction	N/A
	X Walk 1 Width (in)	N/A		X Walk 2 Width (in)	N/A
	X Walk 1 Slope (%)	0.8		X Walk 2 Slope (%)	N/A
	X Walk 1 X Slope (%)	6.2		X Walk 2 X Slope (%)	N/A

N/A	Ramp inside XWalk1?	N/A	N/A	Ramp inside XWalk2?	N/A
	Road Slope (%)	6.2		Clear Space?	N/A
	Road X Slope (%)	0.8	N/A	Clear Space to XWalk (in)	N/A
N/A	Any Obstructions?	N/A	N/A	Storm Grate/Utility Hazard?	N/A
	Obstruction Type			Storm Grate/Utility Type	
		N/A			N/A
			Yes	Surface Condition? (G/P)	Good
			No	Curb Slope (%)	9.2

Remove & Replace Curb Ramp With Two New Directional Ramps or Equivalent.
