# Access Compliance Report

## Public Rights-of-Way

### (Curb Ramps)

Intersection ID: 53401	Main Street: VAWTER_DR	Cross Street: AGNEW_DR	Location: SW
ADA ID: F7A05230472E	Ramp Type: Perp	Initial Pass/Fail: Fail	Overall Compliance: No
		Severity Score: 10

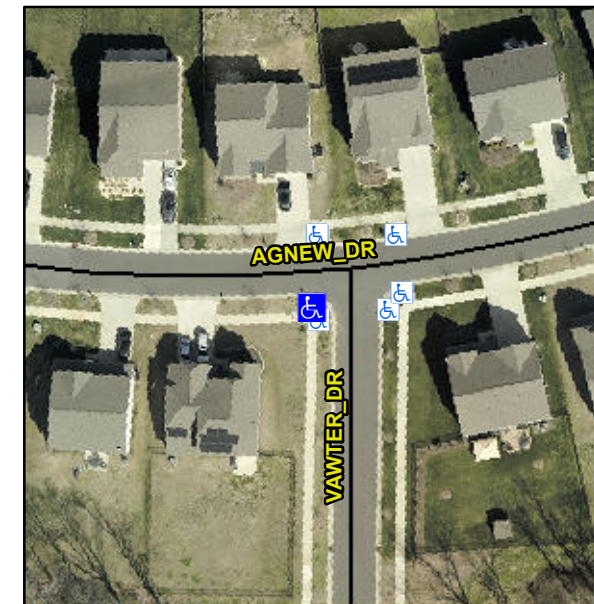
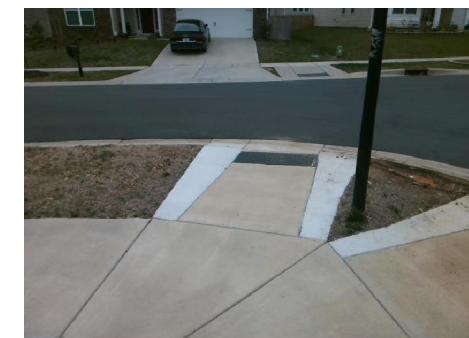
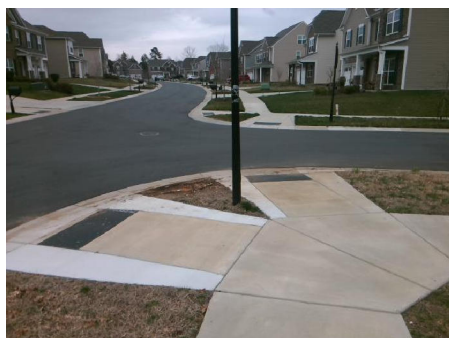
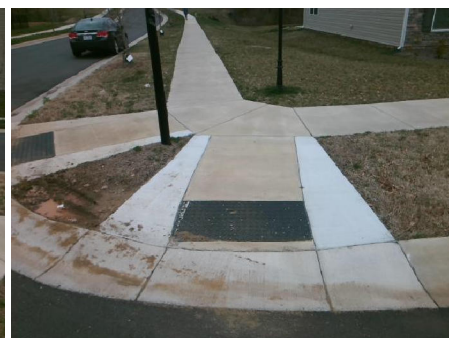
Compliance	Description	Data	Compliance	Description	Data
N/A	Ramp Length (in)	99.0	Yes	Ramp Slope (%)	6.7
No	Ramp Width (in)	47.0	Yes	Ramp XSlope (%)	2.5
N/A	Flare Type LT	N/A	N/A	Flare Type RT	N/A
N/A	Flare Slope LT (%)	N/A	N/A	Flare Slope RT (%)	N/A
N/A	Flare Traversable LT?	N/A	N/A	Flare Traversable RT?	N/A
N/A	Landing Length (in)	N/A	N/A	DWS Provided?	N/A
N/A	Landing Width (in)	N/A	N/A	DWS Contrast?	N/A
N/A	Landing Slope (%)	N/A	N/A	DWS Length (in)	N/A
N/A	Landing X Slope (%)	N/A	N/A	DWS Full Width?	N/A
N/A	Landing Curb? (Y/N)	N/A	N/A	DWS Offset (in)	N/A
N/A	Shared Landing?	N/A			
N/A	Gutter Ponding?	N/A	N/A	Gutter Slope (%)	N/A
N/A	Gutter Lip Ht (in)	N/A	N/A	Gutter X Slope (%)	N/A
N/A	Painted X Walk1?	No	N/A	Painted X Walk2?	N/A
	X Walk 1 Direction	To N		X Walk 2 Direction	N/A
N/A	X Walk 1 Width (in)	N/A	N/A	X Walk 2 Width (in)	N/A
	X Walk 1 Slope (%)	3.3		X Walk 2 Slope (%)	N/A
	X Walk 1 X Slope (%)	2.8		X Walk 2 X Slope (%)	N/A

N/A	Ramp inside XWalk1?	N/A	N/A	Ramp inside XWalk2?	N/A
	Road Slope (%)	N/A	N/A	Clear Space?	N/A
	Road X Slope (%)	N/A	N/A	Clear Space to XWalk (in)	N/A
N/A	Any Obstructions?	N/A	N/A	Storm Grate/Utility Hazard?	N/A
	Obstruction Type			Storm Grate/Utility Type	
		N/A			N/A
			Yes	Surface Condition? (G/P)	Good

**Remove & Replace Entire Ramp.**

**R304.5.1**
