Access Compliance Report

Public Rights-of-Way

(Curb Ramps)

Intersection ID: 14681	Main Street: FAIRWOOD_AV	Cross Street: GRIFFITH_ST	Location: SE
ADA ID: F7AB0EB5DB20	Ramp Type: Perp	Initial Pass/Fail: Fail	Overall Compliance: No
Severity Score: 22.5			
Codes/Mitigation Info/Possible Solution		Field Measurements/Component Compliance

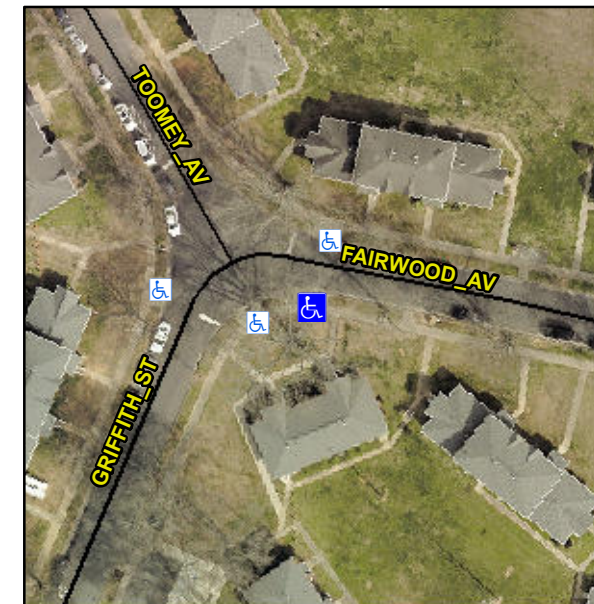
R304.5.1, R304.2.2, R304.5.3

Compliance	Description	Data	Compliance	Description	Data
N/A	Ramp Length (in)	63.0	No	Ramp Slope (%)	8.9
No	Ramp Width (in)	46.5	No	Ramp XSlope (%)	4.9
N/A	Flare Type LT	N/A	N/A	Flare Type RT	N/A
N/A	Flare Slope LT (%)	N/A	N/A	Flare Slope RT (%)	N/A
N/A	Flare Traversable LT?	N/A	N/A	Flare Traversable RT?	N/A
N/A	Landing Length (in)	N/A	N/A	DWS Provided?	N/A
N/A	Landing Width (in)	N/A	N/A	DWS Contrast?	N/A
N/A	Landing Slope (%)	N/A	N/A	DWS Length (in)	N/A
N/A	Landing X Slope (%)	N/A	N/A	DWS Full Width?	N/A
N/A	Landing Curb? (Y/N)	N/A	N/A	DWS Offset (in)	N/A
N/A	Shared Landing?	N/A			
N/A	Gutter Ponding?	N/A	N/A	Gutter Slope (%)	N/A
N/A	Gutter Lip Ht (in)	N/A	N/A	Gutter X Slope (%)	N/A
N/A	Painted X Walk1?	No	N/A	Painted X Walk2?	N/A
	X Walk 1 Direction	To NE		X Walk 2 Direction	N/A
N/A	X Walk 1 Width (in)	N/A	N/A	X Walk 2 Width (in)	N/A
	X Walk 1 Slope (%)	4.9		X Walk 2 Slope (%)	N/A
	X Walk 1 X Slope (%)	2.2		X Walk 2 X Slope (%)	N/A

Remove & Replace Entire Ramp.

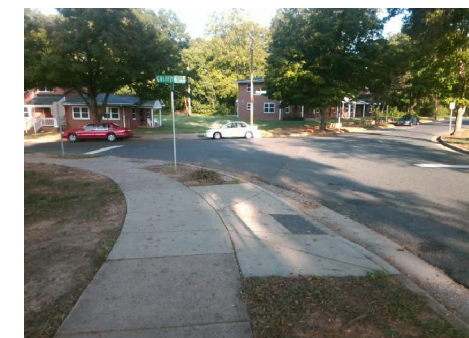
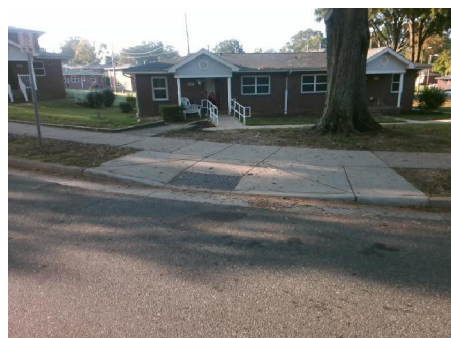
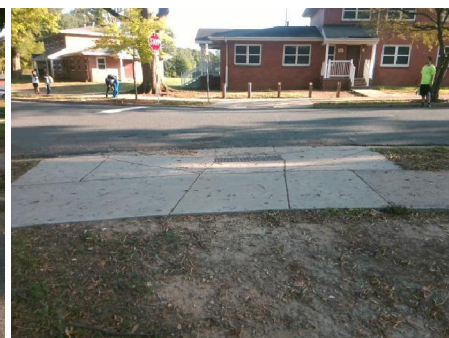
N/A	Ramp inside XWalk1?	N/A	N/A	Ramp inside XWalk2?	N/A
	Road Slope (%)	N/A	N/A	Clear Space?	N/A
	Road X Slope (%)	N/A	N/A	Clear Space to XWalk (in)	N/A
N/A	Any Obstructions?	N/A	N/A	Storm Grate/Utility Hazard?	N/A
	Obstruction Type			Storm Grate/Utility Type	
		N/A			N/A
			Yes	Surface Condition? (G/P)	Good
