Access Compliance Report

Public Rights-of-Way

(Curb Ramps)

Intersection ID: 9801	Main Street: ETHEL_GUEST_LN	Cross Street: RISING_OAK_DR	Location: SE
ADA ID: F7B4C35F4B84	Ramp Type: BlendTrans1	Initial Pass/Fail: Fail	Overall Compliance: No
		Severity Score: 10

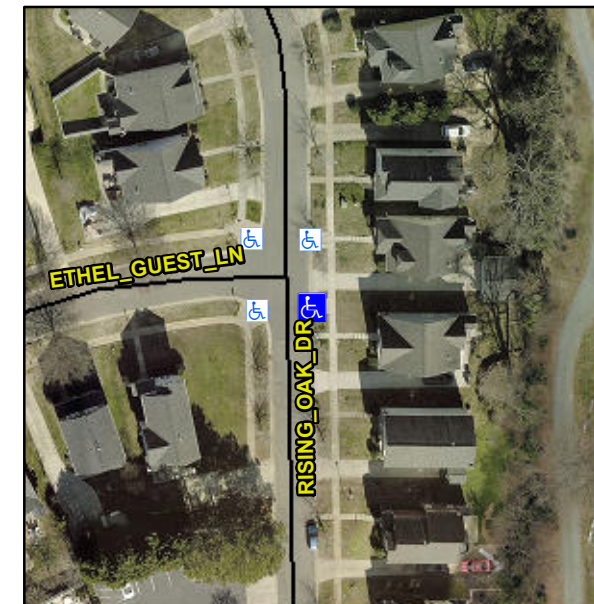
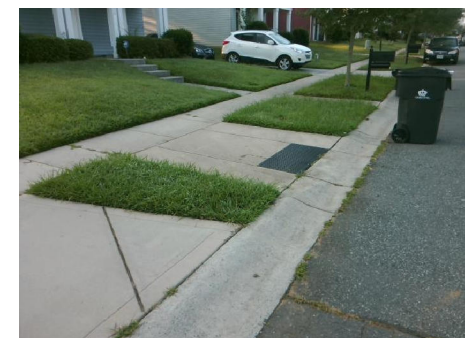
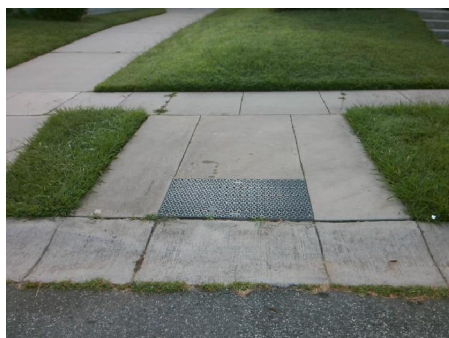
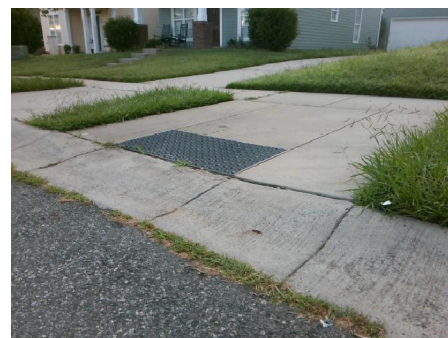
Not Found, R304.5.1, R304.5.3

Compliance	Description	Data	Compliance	Description	Data
N/A	Ramp Length (in)	93.0	Yes	BlendTrans Slope (%)	4.3
No	Ramp Width (in)	47.5	No	BlendTrans XSlope (%)	2.6
N/A	Flare Type LT	N/A	N/A	Flare Type RT	N/A
N/A	Flare Slope LT (%)	N/A	N/A	Flare Slope RT (%)	N/A
N/A	Flare Traversable LT?	N/A	N/A	Flare Traversable RT?	N/A
N/A	Landing Length (in)	N/A	N/A	DWS Provided?	N/A
N/A	Landing Width (in)	N/A	N/A	DWS Contrast?	N/A
N/A	Landing Slope (%)	N/A	N/A	DWS Length (in)	N/A
N/A	Landing X Slope (%)	N/A	N/A	DWS Full Width?	N/A
N/A	Landing Curb? (Y/N)	N/A	N/A	DWS Offset (in)	N/A
N/A	Shared Landing?	N/A			
N/A	Gutter Ponding?	N/A	N/A	Gutter Slope (%)	N/A
N/A	Gutter Lip Ht (in)	N/A	N/A	Gutter X Slope (%)	N/A
N/A	Painted X Walk1?	No	N/A	Painted X Walk2?	N/A
	X Walk 1 Direction	To SE		X Walk 2 Direction	N/A
	X Walk 1 Width (in)	N/A		X Walk 2 Width (in)	N/A
	X Walk 1 Slope (%)	0.9		X Walk 2 Slope (%)	N/A
	X Walk 1 X Slope (%)	1.4		X Walk 2 X Slope (%)	N/A

N/A	Ramp inside XWalk1?	N/A	N/A	Ramp inside XWalk2?	N/A
	Road Slope (%)	1.4		Clear Space?	N/A
	Road X Slope (%)	0.9	N/A	Clear Space to XWalk (in)	N/A
N/A	Any Obstructions?	N/A	N/A	Storm Grate/Utility Hazard?	N/A
	Obstruction Type			Storm Grate/Utility Type	
		N/A			N/A
			Yes	Surface Condition? (G/P)	Good
			No	Curb Slope (%)	16.5

Remove & Replace Curb Ramp With Two New Directional Ramps or Equivalent.
