Access Compliance Report

Public Rights-of-Way

(Curb Ramps)

Intersection ID: 8657	Main Street: HAINES_ST	Cross Street: ST_MARK_ST	Location: NE
ADA ID: F7C8C05CF6F1	Ramp Type: Perp	Initial Pass/Fail: Fail	Overall Compliance: No
		Severity Score: 12.5

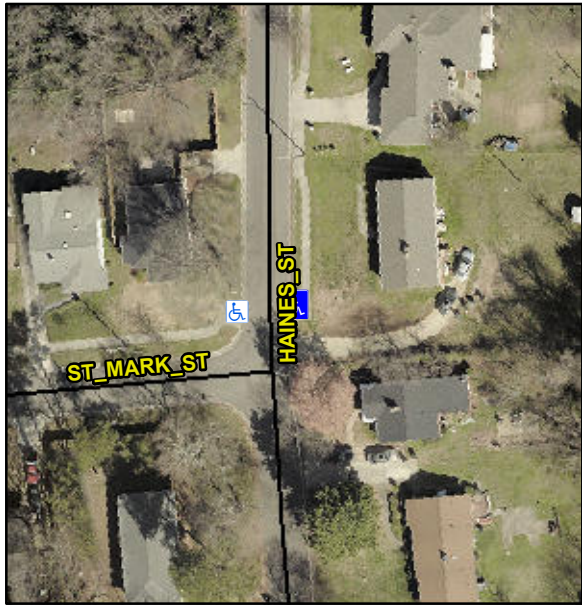
Possible Solutions:			Compliance	Description	Data	Compliance	Description	Data
	Remove & Replace Entire Ramp.			N/A	Ramp Length (in)	108.0	No	Ramp Slope (%)	8.7
				Yes	Ramp Width (in)	48.0	Yes	Ramp XSlope (%)	0.4
				N/A	Flare Type LT	N/A	N/A	Flare Type RT	N/A
				N/A	Flare Slope LT (%)	N/A	N/A	Flare Slope RT (%)	N/A
				N/A	Flare Traversable LT?	N/A	N/A	Flare Traversable RT?	N/A
				N/A	Landing Length (in)	N/A	N/A	DWS Provided?	N/A
				N/A	Landing Width (in)	N/A	N/A	DWS Contrast?	N/A
				N/A	Landing Slope (%)	N/A	N/A	DWS Length (in)	N/A
				N/A	Landing X Slope (%)	N/A	N/A	DWS Full Width?	N/A
				N/A	Landing Curb? (Y/N)	N/A	N/A	DWS Offset (in)	N/A
				N/A	Shared Landing?	N/A			
				N/A	Gutter Ponding?	N/A	N/A	Gutter Slope (%)	N/A
				N/A	Gutter Lip Ht (in)	N/A	N/A	Gutter X Slope (%)	N/A
				N/A	Painted X Walk1?	No	N/A	Painted X Walk2?	N/A

X Walk 1 Direction	To W		X Walk 2 Direction	N/A
				N/A	X Walk 1 Width (in)	N/A	N/A	X Walk 2 Width (in)	N/A
					X Walk 1 Slope (%)	2.1		X Walk 2 Slope (%)	N/A
					X Walk 1 X Slope (%)	2.4		X Walk 2 X Slope (%)	N/A
				N/A	Ramp inside XWalk1?	N/A	N/A	Ramp inside XWalk2?	N/A
				Road Slope (%)	N/A	N/A	Clear Space?	N/A	
				Road X Slope (%)	N/A	N/A	Clear Space to XWalk (in)	N/A	
			N/A	Any Obstructions?	N/A	N/A	Storm Grate/Utility Hazard?	N/A	
				Obstruction Type			Storm Grate/Utility Type		
						N/A		N/A	
						Yes	Surface Condition? (G/P)	Good	
Total Cost:			\$	1850.00					
Street 1 Name				HAINES_ST					
Stop Condition-Street 2				None					
Street 2 Name				N/A					
Stop Condition-Street 1				N/A					
Surveyor Notes:				N/A					
PROW/ADA:				Not Found, R304.2.2
