Access Compliance Report

Public Rights-of-Way

(Curb Ramps)

Intersection ID: 12563	Main Street: E_9TH_ST	Cross Street: N_MYERS_ST	Location: N
ADA ID: F7CEA964BF4D	Ramp Type: PerpDiag	Initial Pass/Fail: Fail	Overall Compliance: No
Severity Score: 42.5			
Codes/Mitigation Info/Possible Solution		Field Measurements/Component Compliance

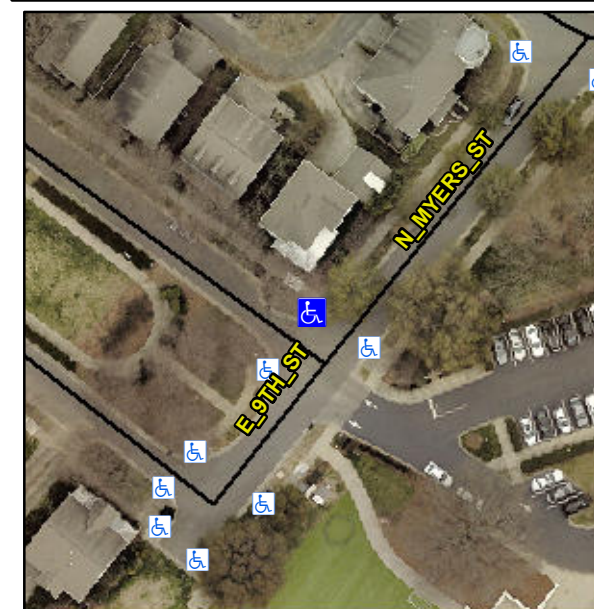
Not Found, R304.5.1, R304.5.3

Compliance	Description	Data	Compliance	Description	Data
N/A	Ramp Length (in)	71.0	Yes	Ramp Slope (%)	6.7
No	Ramp Width (in)	34.0	No	Ramp XSlope (%)	9.1
N/A	Flare Type LT	N/A	N/A	Flare Type RT	N/A
N/A	Flare Slope LT (%)	N/A	N/A	Flare Slope RT (%)	N/A
N/A	Flare Traversable LT?	N/A	N/A	Flare Traversable RT?	N/A
N/A	Landing Length (in)	N/A	N/A	DWS Provided?	N/A
N/A	Landing Width (in)	N/A	N/A	DWS Contrast?	N/A
N/A	Landing Slope (%)	N/A	N/A	DWS Length (in)	N/A
N/A	Landing X Slope (%)	N/A	N/A	DWS Full Width?	N/A
N/A	Landing Curb? (Y/N)	N/A	N/A	DWS Offset (in)	N/A
N/A	Shared Landing?	N/A			
N/A	Gutter Ponding?	N/A	N/A	Gutter Slope (%)	N/A
N/A	Gutter Lip Ht (in)	N/A	N/A	Gutter X Slope (%)	N/A
N/A	Painted X Walk1?	No	N/A	Painted X Walk2?	No
	X Walk 1 Direction	To SW		X Walk 2 Direction	To SE
N/A	X Walk 1 Width (in)	N/A	N/A	X Walk 2 Width (in)	N/A
	X Walk 1 Slope (%)	2.0		X Walk 2 Slope (%)	5.0
	X Walk 1 X Slope (%)	3.1		X Walk 2 X Slope (%)	5.6

N/A	Ramp inside XWalk1?	N/A	N/A	Ramp inside XWalk2?	N/A
	Road Slope (%)	5.1	N/A	Clear Space?	N/A
	Road X Slope (%)	2.5	N/A	Clear Space to XWalk (in)	N/A
N/A	Any Obstructions?	N/A	N/A	Storm Grate/Utility Hazard?	N/A
	Obstruction Type			Storm Grate/Utility Type	
		N/A			N/A
		Yes		Surface Condition? (G/P)	Good

Remove & Replace Curb Ramp With Two New Directional Ramps or Equivalent.
