Access Compliance Report Public Rights-of-Way (Curb Ramps)

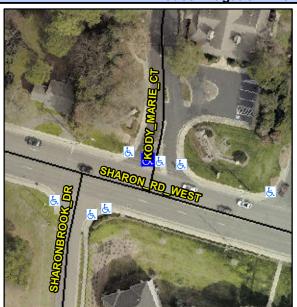
Intersection ID: 23300Main Street: SHARON_RD_WESTCross Street: SHARONBROOK_DRLocation:NEADA ID: F7CF940F3B07Ramp Type: PerpInitial Pass/Fail: FailOverall Compliance: NoSeverity Score: 12.5

Compliance Description Data Compliance Description Data No N/A Ramp Length (in) 59.0 Ramp Slope (%) 10.8 Yes Ramp XSlope (%) Yes Ramp Width (in) 48.0 0.4 N/A N/A Flare Type LT N/A Flare Type RT N/A N/A Flare Slope LT (%) N/A N/A Flare Slope RT (%) N/A N/A Flare Traversable LT? N/A N/A Flare Traversable RT? N/A N/A Landing Length (in) N/A N/A DWS Provided? N/A N/A Landing Width (in) N/A N/A **DWS Contrast?** N/A N/A N/A N/A Landing Slope (%) DWS Length (in) N/A N/A Landing X Slope (%) N/A N/A DWS Full Width? N/A N/A Landing Curb? (Y/N) N/A N/A DWS Offset (in) N/A N/A N/A Shared Landing? N/A **Gutter Ponding?** N/A N/A Gutter Slope (%) N/A N/A Gutter Lip Ht (in) N/A N/A Gutter X Slope (%) N/A N/A Painted X Walk1? No N/A Painted X Walk2? N/A X Walk 1 Direction To NW X Walk 2 Direction N/A N/A N/A N/A X Walk 2 Width (in) X Walk 1 Width (in) N/A X Walk 1 Slope (%) 0.2 X Walk 2 Slope (%) N/A X Walk 1 X Slope (%) 2.6 X Walk 2 X Slope (%) N/A N/A N/A N/A Ramp inside XWalk2? Ramp inside XWalk1? N/A Road Slope (%) N/A N/A Clear Space? N/A N/A Road X Slope (%) N/A Clear Space to XWalk (in) N/A N/A N/A Any Obstructions? N/A Storm Grate/Utility Hazard? N/A **Obstruction Type** Storm Grate/Utility Type N/A N/A Yes Surface Condition? (G/P) Good

Remove & Replace Entire Ramp.

R304.2.2
