Access Compliance Report

Public Rights-of-Way

(Curb Ramps)

Intersection ID: 10036927	Main Street: S_SHARON_AMITY_RD	Cross Street: N/A	Location: NW
ADA ID: F7E02D30DA66	Ramp Type: Perp	Initial Pass/Fail: Fail	Overall Compliance: No
Severity Score: 33.75			
Codes/Mitigation Info/Possible Solution		Field Measurements/Component Compliance

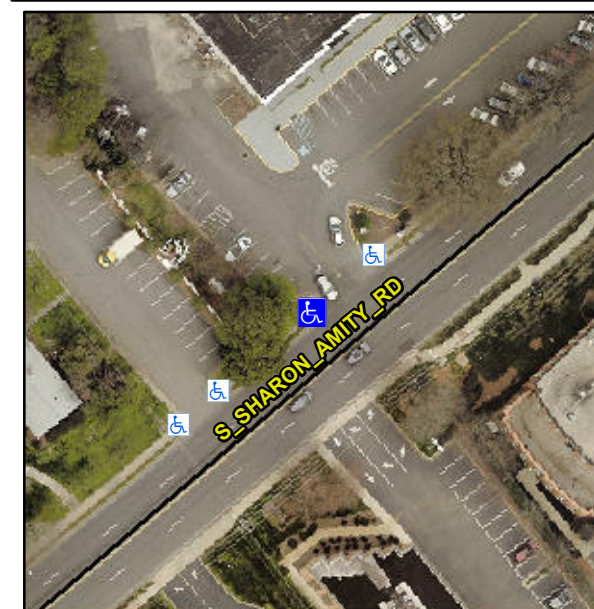
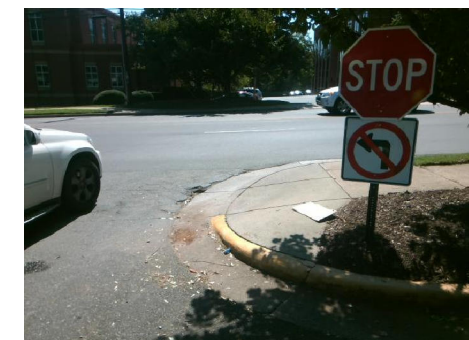
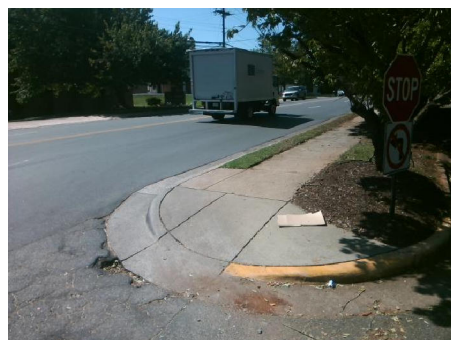
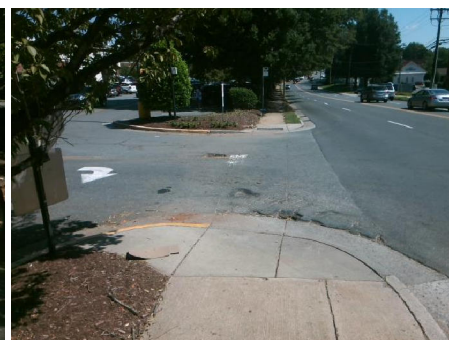
Not Found, R304.5.1, R304.2.2

Compliance	Description	Data	Compliance	Description	Data
N/A	Ramp Length (in)	64.0	No	Ramp Slope (%)	16.9
No	Ramp Width (in)	41.0	Yes	Ramp XSlope (%)	1.4
N/A	Flare Type LT	N/A	N/A	Flare Type RT	N/A
N/A	Flare Slope LT (%)	N/A	N/A	Flare Slope RT (%)	N/A
N/A	Flare Traversable LT?	N/A	N/A	Flare Traversable RT?	N/A
N/A	Landing Length (in)	N/A	N/A	DWS Provided?	N/A
N/A	Landing Width (in)	N/A	N/A	DWS Contrast?	N/A
N/A	Landing Slope (%)	N/A	N/A	DWS Length (in)	N/A
N/A	Landing X Slope (%)	N/A	N/A	DWS Full Width?	N/A
N/A	Landing Curb? (Y/N)	N/A	N/A	DWS Offset (in)	N/A
N/A	Shared Landing?	N/A			
N/A	Gutter Ponding?	N/A	N/A	Gutter Slope (%)	N/A
N/A	Gutter Lip Ht (in)	N/A	N/A	Gutter X Slope (%)	N/A
N/A	Painted X Walk1?	No	N/A	Painted X Walk2?	N/A
	X Walk 1 Direction	To E		X Walk 2 Direction	N/A
N/A	X Walk 1 Width (in)	N/A	N/A	X Walk 2 Width (in)	N/A
	X Walk 1 Slope (%)	1.2		X Walk 2 Slope (%)	N/A
	X Walk 1 X Slope (%)	1.9		X Walk 2 X Slope (%)	N/A

N/A	Ramp inside XWalk1?	N/A	N/A	Ramp inside XWalk2?	N/A
	Road Slope (%)	N/A	N/A	Clear Space?	N/A
	Road X Slope (%)	N/A	N/A	Clear Space to XWalk (in)	N/A
N/A	Any Obstructions?	N/A	N/A	Storm Grate/Utility Hazard?	N/A
	Obstruction Type			Storm Grate/Utility Type	
		N/A			N/A
			Yes	Surface Condition? (G/P)	Good

Possible Solutions:

Remove & Replace Entire Ramp.

Total Cost: \$ 1850.00
