Access Compliance Report

Public Rights-of-Way (Curb Ramps)

Intersection ID: 10037245	Main Street: SARDIS_CROSSING_DR	Cross Street: N/A	Location: NE
ADA ID: F7E06A6881B0	Ramp Type: PerpDiag	Initial Pass/Fail: Fail	Overall Compliance: No
Severity Score: 21.25			
Codes/Mitigation Info/Possible Solution		Field Measurements/Component Compliance

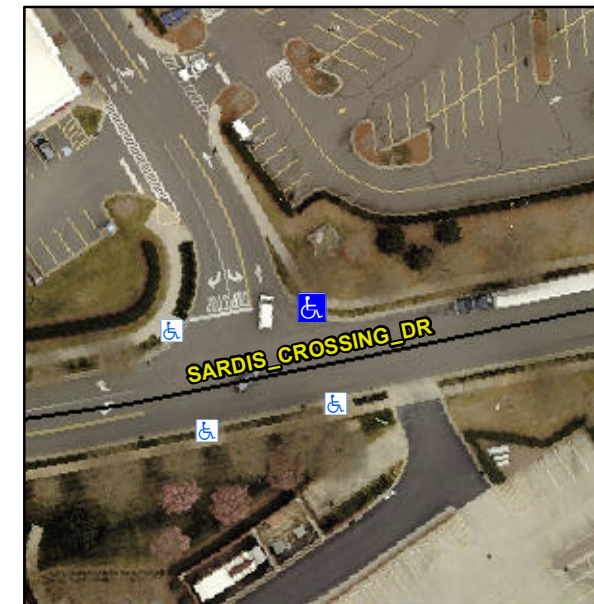
Compliance	Description	Data	Compliance	Description	Data
N/A	Ramp Length (in)	47.0	No	Ramp Slope (%)	10.8
No	Ramp Width (in)	43.0	Yes	Ramp XSlope (%)	0.1
N/A	Flare Type LT	N/A	N/A	Flare Type RT	N/A
N/A	Flare Slope LT (%)	N/A	N/A	Flare Slope RT (%)	N/A
N/A	Flare Traversable LT?	N/A	N/A	Flare Traversable RT?	N/A
N/A	Landing Length (in)	N/A	N/A	DWS Provided?	N/A
N/A	Landing Width (in)	N/A	N/A	DWS Contrast?	N/A
N/A	Landing Slope (%)	N/A	N/A	DWS Length (in)	N/A
N/A	Landing X Slope (%)	N/A	N/A	DWS Full Width?	N/A
N/A	Landing Curb? (Y/N)	N/A	N/A	DWS Offset (in)	N/A
N/A	Shared Landing?	N/A			
N/A	Gutter Ponding?	N/A	N/A	Gutter Slope (%)	N/A
N/A	Gutter Lip Ht (in)	N/A	N/A	Gutter X Slope (%)	N/A
N/A	Painted X Walk1?	No	N/A	Painted X Walk2?	No
	X Walk 1 Direction	To W		X Walk 2 Direction	To S
N/A	X Walk 1 Width (in)	N/A	N/A	X Walk 2 Width (in)	N/A
	X Walk 1 Slope (%)	3.8		X Walk 2 Slope (%)	5.1
	X Walk 1 X Slope (%)	3.5		X Walk 2 X Slope (%)	2.4

N/A	Ramp inside XWalk1?	N/A	N/A	Ramp inside XWalk2?	N/A
	Road Slope (%)	4.1	N/A	Clear Space?	N/A
	Road X Slope (%)	2.8	N/A	Clear Space to XWalk (in)	N/A
N/A	Any Obstructions?	N/A	N/A	Storm Grate/Utility Hazard?	N/A
	Obstruction Type			Storm Grate/Utility Type	
		N/A			N/A
		Yes		Surface Condition? (G/P)	Good

Possible Solutions:

Remove & Replace Curb Ramp With Two New Directional Ramps or Equivalent.
