## **Access Compliance Report Public Rights-of-Way** (Curb Ramps)

Intersection ID: 11101 Main Street: DRUMMOND AV Cross Street: EVERETT PL Location: S **Overall Compliance: No Severity Score:** ADA ID: F7E6710D9334 Ramp Type: Perp Initial Pass/Fail: Fail 37.5

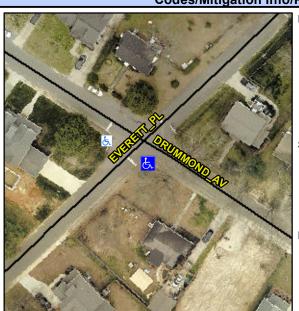
**EVERETT PL** Street 1 Name Stop Condition-Street 2 StopSign N/A Street 2 Name Stop Condition-Street 1 N/A Possible Solutions: Compliance Description N/A Remove & Replace Entire Ramp. Yes N/A N/A Surveyor Notes: N/A PROW/ADA: Not Found, R304.2.2, R304.5.3
