Access Compliance Report

Public Rights-of-Way

(Curb Ramps)

Intersection ID: 21497	Main Street: GREENWAY_VIEW_CT	Cross Street: WITHERS_MILL_DR	Location:	N
ADA ID: F7EA137B0D44	Ramp Type: BlendTrans2	Initial Pass/Fail: Fail	Overall Compliance: No	Severity Score: 35

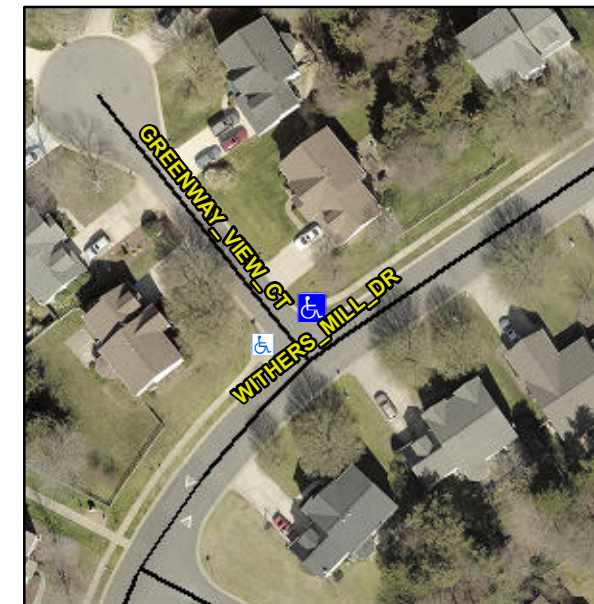
Compliance	Description	Data	Compliance	Description	Data
N/A	Ramp Length (in)	102.0	Yes	BlendTrans Slope (%)	2.1
No	Ramp Width (in)	24.0	Yes	BlendTrans XSlope (%)	0.0
N/A	Flare Type LT	N/A	N/A	Flare Type RT	N/A
N/A	Flare Slope LT (%)	N/A	N/A	Flare Slope RT (%)	N/A
N/A	Flare Traversable LT?	N/A	N/A	Flare Traversable RT?	N/A
N/A	Landing Length (in)	N/A	N/A	DWS Provided?	N/A
N/A	Landing Width (in)	N/A	N/A	DWS Contrast?	N/A
N/A	Landing Slope (%)	N/A	N/A	DWS Length (in)	N/A
N/A	Landing X Slope (%)	N/A	N/A	DWS Full Width?	N/A
N/A	Landing Curb? (Y/N)	N/A	N/A	DWS Offset (in)	N/A
N/A	Shared Landing?	N/A			
N/A	Gutter Ponding?	N/A	N/A	Gutter Slope (%)	N/A
N/A	Gutter Lip Ht (in)	N/A	N/A	Gutter X Slope (%)	N/A
N/A	Painted X Walk1?	No	N/A	Painted X Walk2?	No
	X Walk 1 Direction	To SW		X Walk 2 Direction	To SE
	X Walk 1 Width (in)	N/A		X Walk 2 Width (in)	N/A
	X Walk 1 Slope (%)	2.2		X Walk 2 Slope (%)	2.1
	X Walk 1 X Slope (%)	1.7		X Walk 2 X Slope (%)	2.2

N/A	Ramp inside XWalk1?	N/A	N/A	Ramp inside XWalk2?	N/A
	Road Slope (%)	0.9		Clear Space?	N/A
	Road X Slope (%)	3.0	N/A	Clear Space to XWalk (in)	N/A
N/A	Any Obstructions?	N/A	N/A	Storm Grate/Utility Hazard?	N/A
	Obstruction Type			Storm Grate/Utility Type	
		N/A			N/A
			Yes	Surface Condition? (G/P)	Good
			N/A	Curb Slope (%)	1.9

Remove & Replace Curb Ramp With Two New Directional Ramps or Equivalent.

R304.5.1
