Access Compliance Report

Public Rights-of-Way

(Curb Ramps)

Intersection ID: 10671	Main Street: PLYMOUTH_AV	Cross Street: GRIMES_ST	Location: S
ADA ID: F7F012209E04	Ramp Type: Perp	Initial Pass/Fail: Fail	Overall Compliance: No
Severity Score: 8.75			
Codes/Mitigation Info/Possible Solution		Field Measurements/Component Compliance

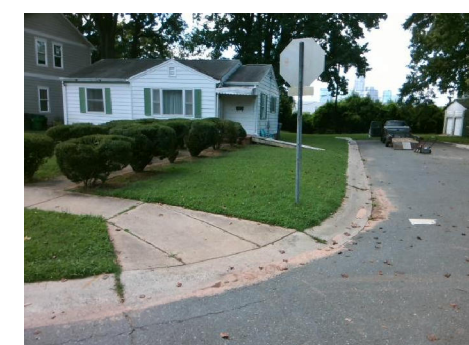
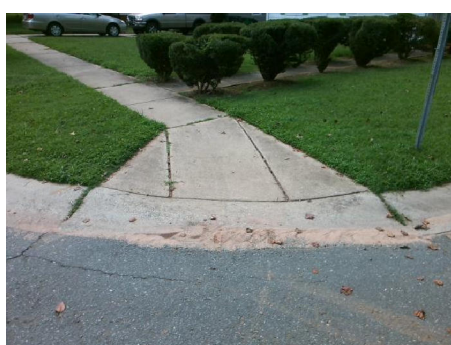
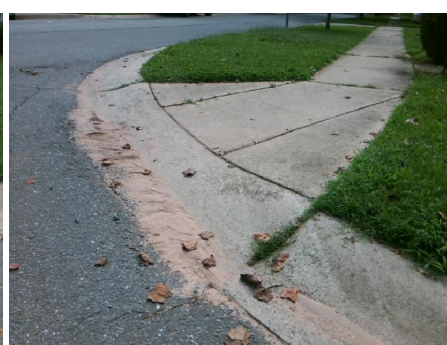
Compliance	Description	Data	Compliance	Description	Data
N/A	Ramp Length (in)	73.5	Yes	Ramp Slope (%)	6.6
No	Ramp Width (in)	40.0	Yes	Ramp XSlope (%)	1.4
N/A	Flare Type LT	N/A	N/A	Flare Type RT	N/A
N/A	Flare Slope LT (%)	N/A	N/A	Flare Slope RT (%)	N/A
N/A	Flare Traversable LT?	N/A	N/A	Flare Traversable RT?	N/A
N/A	Landing Length (in)	N/A	N/A	DWS Provided?	N/A
N/A	Landing Width (in)	N/A	N/A	DWS Contrast?	N/A
N/A	Landing Slope (%)	N/A	N/A	DWS Length (in)	N/A
N/A	Landing X Slope (%)	N/A	N/A	DWS Full Width?	N/A
N/A	Landing Curb? (Y/N)	N/A	N/A	DWS Offset (in)	N/A
N/A	Shared Landing?	N/A			
N/A	Gutter Ponding?	Yes	N/A	Gutter Slope (%)	N/A
N/A	Gutter Lip Ht (in)	N/A	N/A	Gutter X Slope (%)	N/A
N/A	Painted X Walk1?	No	N/A	Painted X Walk2?	N/A
	X Walk 1 Direction	To NW		X Walk 2 Direction	N/A
N/A	X Walk 1 Width (in)	N/A	N/A	X Walk 2 Width (in)	N/A
	X Walk 1 Slope (%)	6.0		X Walk 2 Slope (%)	N/A
	X Walk 1 X Slope (%)	3.4		X Walk 2 X Slope (%)	N/A

N/A	Ramp inside XWalk1?	N/A	N/A	Ramp inside XWalk2?	N/A
	Road Slope (%)	N/A	N/A	Clear Space?	N/A
	Road X Slope (%)	N/A	N/A	Clear Space to XWalk (in)	N/A
N/A	Any Obstructions?	N/A	N/A	Storm Grate/Utility Hazard?	N/A
	Obstruction Type			Storm Grate/Utility Type	
		N/A			N/A
		Yes		Surface Condition? (G/P)	Good

Possible Solutions:

Remove & Replace Entire Ramp.
