# Access Compliance Report

## Public Rights-of-Way

### (Curb Ramps)

Intersection ID: 32118	Main Street: COLE_MILL_RD	Cross Street: DUNDALK_RD	Location: E
ADA ID: F80482491501	Ramp Type: PerpDiag	Initial Pass/Fail: Fail	Overall Compliance: No
Codes/Mitigation Info/Possible Solution			Severity Score: 10
			Field Measurements/Component Compliance

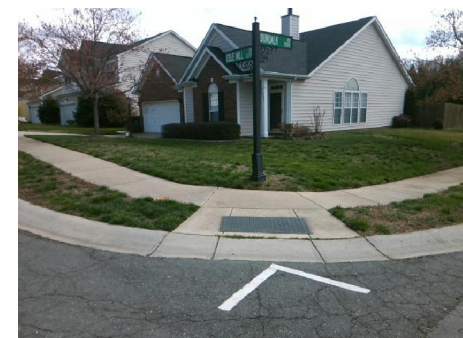
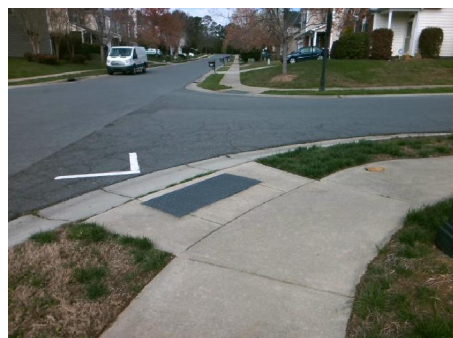
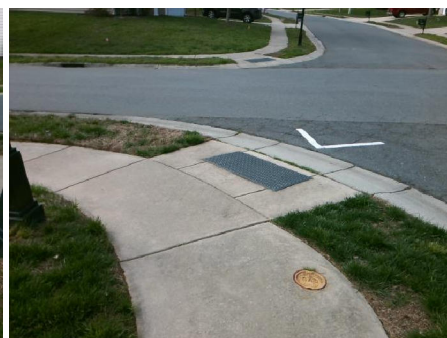
**Not Found, R304.5.1, R304.5.3**

Compliance	Description	Data	Compliance	Description	Data
N/A	Ramp Length (in)	48.0	Yes	Ramp Slope (%)	5.0
No	Ramp Width (in)	37.5	No	Ramp XSlope (%)	4.4
N/A	Flare Type LT	N/A	N/A	Flare Type RT	N/A
N/A	Flare Slope LT (%)	N/A	N/A	Flare Slope RT (%)	N/A
N/A	Flare Traversable LT?	N/A	N/A	Flare Traversable RT?	N/A
N/A	Landing Length (in)	N/A	N/A	DWS Provided?	N/A
N/A	Landing Width (in)	N/A	N/A	DWS Contrast?	N/A
N/A	Landing Slope (%)	N/A	N/A	DWS Length (in)	N/A
N/A	Landing X Slope (%)	N/A	N/A	DWS Full Width?	N/A
N/A	Landing Curb? (Y/N)	N/A	N/A	DWS Offset (in)	N/A
N/A	Shared Landing?	N/A			
N/A	Gutter Ponding?	N/A	N/A	Gutter Slope (%)	N/A
N/A	Gutter Lip Ht (in)	N/A	N/A	Gutter X Slope (%)	N/A
N/A	Painted X Walk1?	No	N/A	Painted X Walk2?	No
	X Walk 1 Direction	To NW		X Walk 2 Direction	To SW
N/A	X Walk 1 Width (in)	N/A	N/A	X Walk 2 Width (in)	N/A
	X Walk 1 Slope (%)	3.8		X Walk 2 Slope (%)	0.4
	X Walk 1 X Slope (%)	2.1		X Walk 2 X Slope (%)	2.7

N/A	Ramp inside XWalk1?	N/A	N/A	Ramp inside XWalk2?	N/A
	Road Slope (%)	3.4	N/A	Clear Space?	N/A
	Road X Slope (%)	1.4	N/A	Clear Space to XWalk (in)	N/A
N/A	Any Obstructions?	N/A	N/A	Storm Grate/Utility Hazard?	N/A
	Obstruction Type			Storm Grate/Utility Type	
		N/A			N/A
			Yes	Surface Condition? (G/P)	Good

**Remove & Replace Curb Ramp With Two New Directional Ramps or Equivalent.**
