Access Compliance Report

Public Rights-of-Way

(Curb Ramps)

Intersection ID: 49931	Main Street: WOBURN_RD	Cross Street: ASHBOURNE_HALL_RD	Location: SW
ADA ID: F80E1CB3560B	Ramp Type: Perp	Initial Pass/Fail: Fail	Overall Compliance: No
Severity Score: 25			
Codes/Mitigation Info/Possible Solution		Field Measurements/Component Compliance

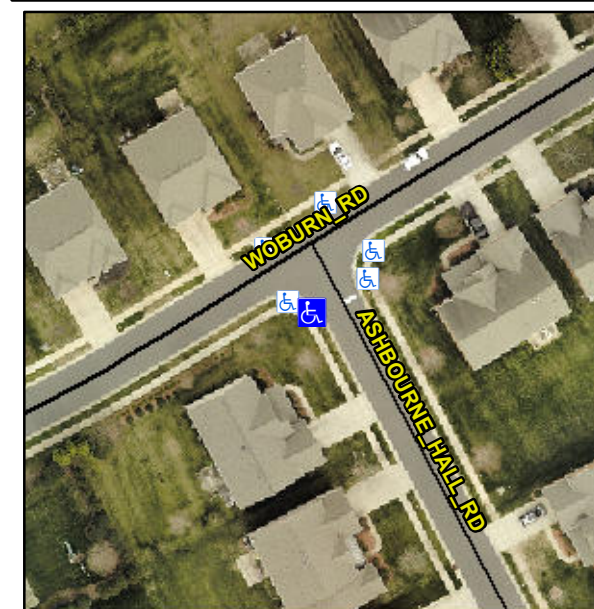
Not Found, R304.2.2, R304.5.3

Compliance	Description	Data	Compliance	Description	Data
N/A	Ramp Length (in)	47.0	No	Ramp Slope (%)	9.0
Yes	Ramp Width (in)	48.0	No	Ramp XSlope (%)	5.3
N/A	Flare Type LT	N/A	N/A	Flare Type RT	N/A
N/A	Flare Slope LT (%)	N/A	N/A	Flare Slope RT (%)	N/A
N/A	Flare Traversable LT?	N/A	N/A	Flare Traversable RT?	N/A
N/A	Landing Length (in)	N/A	N/A	DWS Provided?	N/A
N/A	Landing Width (in)	N/A	N/A	DWS Contrast?	N/A
N/A	Landing Slope (%)	N/A	N/A	DWS Length (in)	N/A
N/A	Landing X Slope (%)	N/A	N/A	DWS Full Width?	N/A
N/A	Landing Curb? (Y/N)	N/A	N/A	DWS Offset (in)	N/A
N/A	Shared Landing?	N/A			
N/A	Gutter Ponding?	N/A	N/A	Gutter Slope (%)	N/A
N/A	Gutter Lip Ht (in)	N/A	N/A	Gutter X Slope (%)	N/A
N/A	Painted X Walk1?	No	N/A	Painted X Walk2?	N/A
	X Walk 1 Direction	To NE		X Walk 2 Direction	N/A
N/A	X Walk 1 Width (in)	N/A	N/A	X Walk 2 Width (in)	N/A
	X Walk 1 Slope (%)	1.8		X Walk 2 Slope (%)	N/A
	X Walk 1 X Slope (%)	1.6		X Walk 2 X Slope (%)	N/A

N/A	Ramp inside XWalk1?	N/A	N/A	Ramp inside XWalk2?	N/A
	Road Slope (%)	N/A	N/A	Clear Space?	N/A
	Road X Slope (%)	N/A	N/A	Clear Space to XWalk (in)	N/A
N/A	Any Obstructions?	N/A	N/A	Storm Grate/Utility Hazard?	N/A
	Obstruction Type			Storm Grate/Utility Type	
		N/A			N/A
			Yes	Surface Condition? (G/P)	Good

Possible Solutions:

Remove & Replace Entire Ramp.
