Access Compliance Report

Public Rights-of-Way

(Curb Ramps)

Intersection ID: 11082	Main Street: E_35TH_ST	Cross Street: MURDOCK_RD	Location: NE
ADA ID: F81674259B2B	Ramp Type: Perp	Initial Pass/Fail: Fail	Overall Compliance: No
Severity Score: 10			
Codes/Mitigation Info/Possible Solution		Field Measurements/Component Compliance

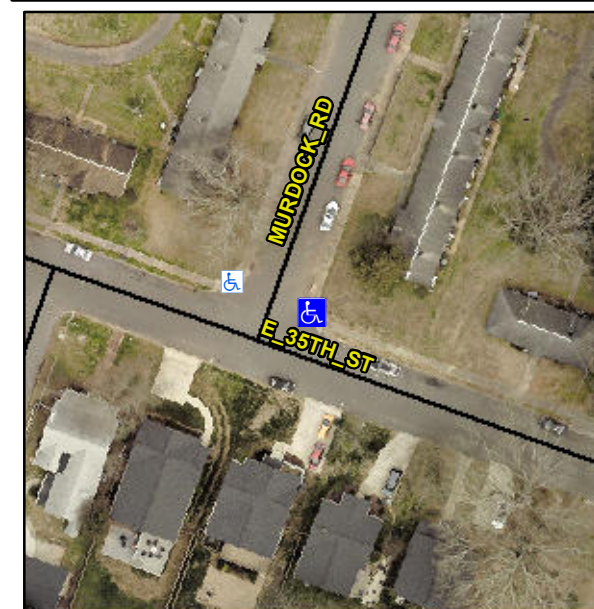
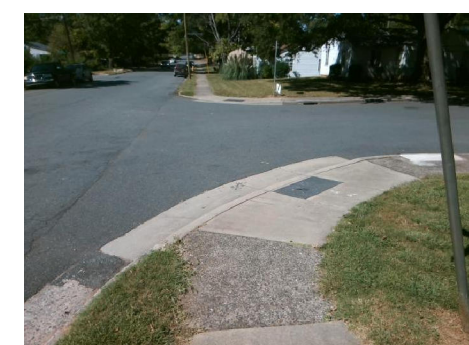
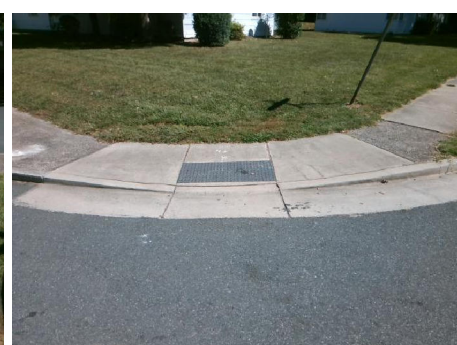
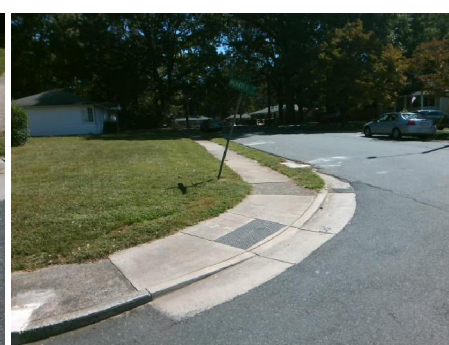
Not Found, R304.5.1, R304.5.3

Compliance	Description	Data	Compliance	Description	Data
N/A	Ramp Length (in)	59.0	Yes	Ramp Slope (%)	5.2
No	Ramp Width (in)	46.5	No	Ramp XSlope (%)	4.5
N/A	Flare Type LT	N/A	N/A	Flare Type RT	N/A
N/A	Flare Slope LT (%)	N/A	N/A	Flare Slope RT (%)	N/A
N/A	Flare Traversable LT?	N/A	N/A	Flare Traversable RT?	N/A
N/A	Landing Length (in)	N/A	N/A	DWS Provided?	N/A
N/A	Landing Width (in)	N/A	N/A	DWS Contrast?	N/A
N/A	Landing Slope (%)	N/A	N/A	DWS Length (in)	N/A
N/A	Landing X Slope (%)	N/A	N/A	DWS Full Width?	N/A
N/A	Landing Curb? (Y/N)	N/A	N/A	DWS Offset (in)	N/A
N/A	Shared Landing?	N/A			
N/A	Gutter Ponding?	N/A	N/A	Gutter Slope (%)	N/A
N/A	Gutter Lip Ht (in)	N/A	N/A	Gutter X Slope (%)	N/A
N/A	Painted X Walk1?	No	N/A	Painted X Walk2?	N/A
	X Walk 1 Direction	To NW		X Walk 2 Direction	N/A
N/A	X Walk 1 Width (in)	N/A	N/A	X Walk 2 Width (in)	N/A
	X Walk 1 Slope (%)	0.2		X Walk 2 Slope (%)	N/A
	X Walk 1 X Slope (%)	1.4		X Walk 2 X Slope (%)	N/A

N/A	Ramp inside XWalk1?	N/A	N/A	Ramp inside XWalk2?	N/A
	Road Slope (%)	N/A	N/A	Clear Space?	N/A
	Road X Slope (%)	N/A	N/A	Clear Space to XWalk (in)	N/A
N/A	Any Obstructions?	N/A	N/A	Storm Grate/Utility Hazard?	N/A
	Obstruction Type			Storm Grate/Utility Type	
		N/A			N/A
			Yes	Surface Condition? (G/P)	Good

Possible Solutions:

Remove & Replace Entire Ramp.
