Access Compliance Report

Public Rights-of-Way

(Curb Ramps)

Intersection ID: 16745	Main Street: MARYLAND_AV	Cross Street: PRINCETON_AV	Location: NW
ADA ID: F82BDBE34DA2	Ramp Type: PerpDiag	Initial Pass/Fail: Fail	Overall Compliance: No
			Severity Score: 13.75

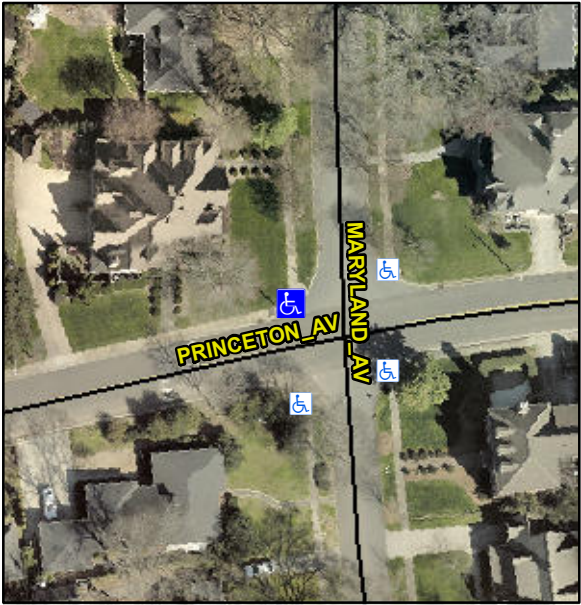
Possible Solutions:		Compliance	Description	Data
	Remove & Replace Curb Ramp With Two New Directional Ramps or Equivalent.		No	Ramp Length (in)	86.0
			Yes	Ramp Width (in)	48.0
			N/A	Flare Type LT	N/A
			N/A	Flare Slope LT (%)	N/A
			N/A	Flare Traversable LT?	N/A
			N/A	Landing Length (in)	N/A
			N/A	Landing Width (in)	N/A
			N/A	Landing Slope (%)	N/A
			N/A	Landing X Slope (%)	N/A
<p>Surveyor Notes:</p> <p>N/A</p> <p>PROW/ADA:</p> <p>R304.2.2, R304.5.3</p>			N/A	Flare Type RT	N/A
			N/A	Flare Slope RT (%)	N/A
			N/A	Flare Traversable RT?	N/A
			N/A	DWS Provided?	N/A
			N/A	DWS Contrast?	N/A
			N/A	DWS Length (in)	N/A
			N/A	DWS Full Width?	N/A
			N/A	DWS Offset (in)	N/A
			N/A	Gutter Ponding?	N/A
			N/A	Gutter Lip Ht (in)	N/A
<p>Total Cost:</p> <p>\$ 3200.00</p>			No	Painted X Walk2?	No
			To S	X Walk 2 Direction	To E
			N/A	X Walk 2 Width (in)	N/A

0.7	X Walk 2 Slope (%)	4.3
			4.1	X Walk 2 X Slope (%)	1.1
			N/A	Ramp inside XWalk2?	N/A
			3.9	Clear Space?	N/A
			2.8	Clear Space to XWalk (in)	N/A
			N/A	Storm Grate/Utility Hazard?	N/A
			N/A	Storm Grate/Utility Type	N/A
			N/A	Surface Condition? (G/P)	Good
