Access Compliance Report

Public Rights-of-Way

(Curb Ramps)

Intersection ID: 13679	Main Street: EUCLID_AV	Cross Street: LEXINGTON_AV	Location: N
ADA ID: F833104E9BD9	Ramp Type: PerpDiag	Initial Pass/Fail: Fail	Overall Compliance: No
Severity Score: 26.25

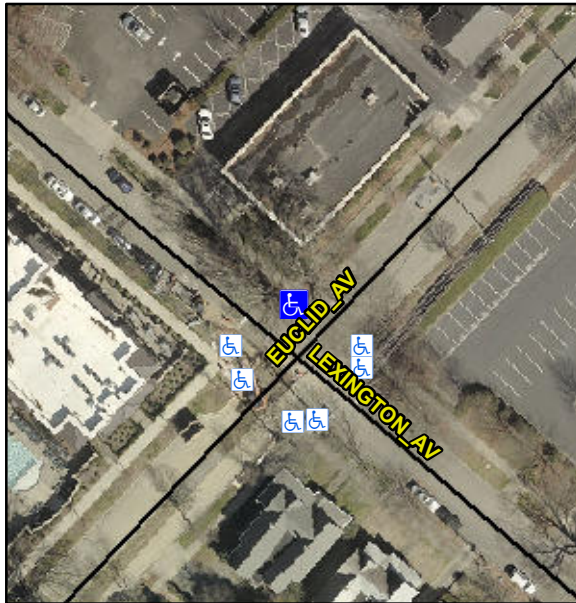
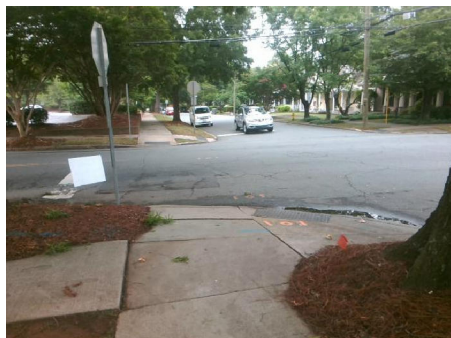
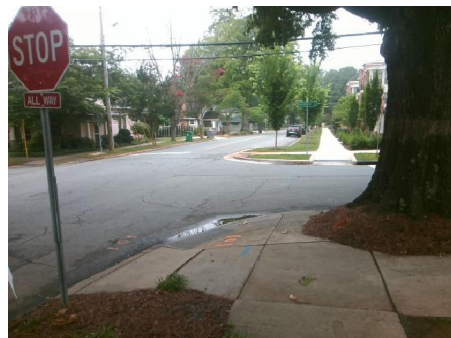
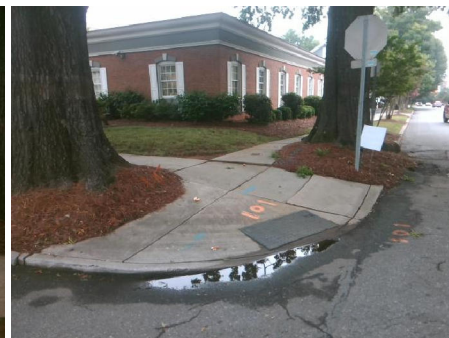
Not Found, R304.2.2, R304.5.3

Compliance	Description	Data	Compliance	Description	Data
N/A	Ramp Length (in)	101.0	No	Ramp Slope (%)	16.2
Yes	Ramp Width (in)	72.0	No	Ramp XSlope (%)	2.9
N/A	Flare Type LT	N/A	N/A	Flare Type RT	N/A
N/A	Flare Slope LT (%)	N/A	N/A	Flare Slope RT (%)	N/A
N/A	Flare Traversable LT?	N/A	N/A	Flare Traversable RT?	N/A
N/A	Landing Length (in)	N/A	N/A	DWS Provided?	N/A
N/A	Landing Width (in)	N/A	N/A	DWS Contrast?	N/A
N/A	Landing Slope (%)	N/A	N/A	DWS Length (in)	N/A
N/A	Landing X Slope (%)	N/A	N/A	DWS Full Width?	N/A
N/A	Landing Curb? (Y/N)	N/A	N/A	DWS Offset (in)	N/A
N/A	Shared Landing?	N/A			
N/A	Gutter Ponding?	Yes	N/A	Gutter Slope (%)	N/A
N/A	Gutter Lip Ht (in)	N/A	N/A	Gutter X Slope (%)	N/A
N/A	Painted X Walk1?	No	N/A	Painted X Walk2?	No
	X Walk 1 Direction	To SW		X Walk 2 Direction	To SE
N/A	X Walk 1 Width (in)	N/A	N/A	X Walk 2 Width (in)	N/A
	X Walk 1 Slope (%)	1.2		X Walk 2 Slope (%)	1.6
	X Walk 1 X Slope (%)	0.9		X Walk 2 X Slope (%)	0.3

N/A	Ramp inside XWalk1?	N/A	N/A	Ramp inside XWalk2?	N/A
	Road Slope (%)	1.3	N/A	Clear Space?	N/A
	Road X Slope (%)	3.1	N/A	Clear Space to XWalk (in)	N/A
N/A	Any Obstructions?	N/A	N/A	Storm Grate/Utility Hazard?	N/A
	Obstruction Type			Storm Grate/Utility Type	
		N/A			N/A
		Yes		Surface Condition? (G/P)	Good

Remove & Replace Curb Ramp With Two New Directional Ramps or Equivalent.
