Access Compliance Report

Public Rights-of-Way

(Curb Ramps)

Intersection ID: 8226	Main Street: CATHERINE_SIMMONS_AV	Cross Street: CUSTER_ST	Location: SE
ADA ID: F8340F4BAE3D	Ramp Type: BlendTrans2	Initial Pass/Fail: Fail	Overall Compliance: No
Codes/Mitigation Info/Possible Solution		Field Measurements/Component Compliance	
Severity Score: 12.5

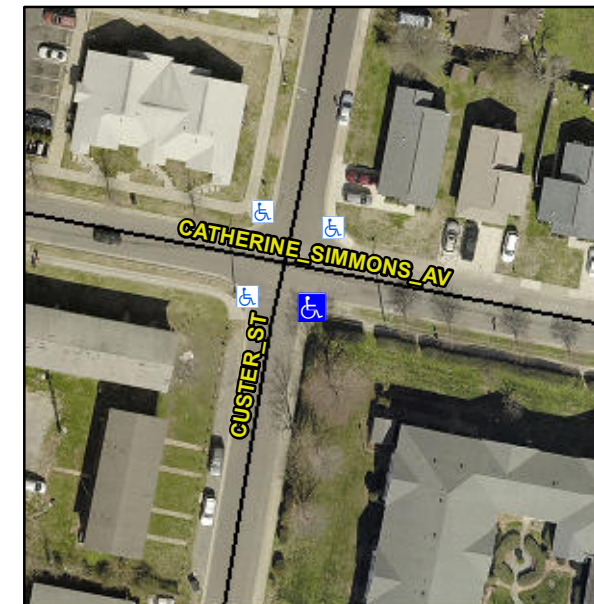
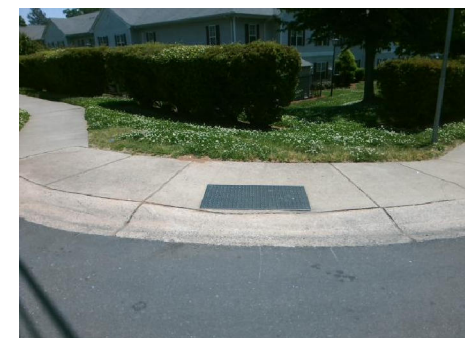
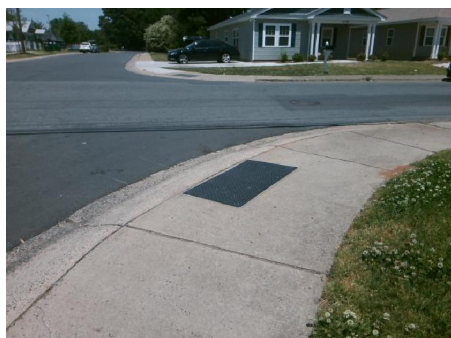
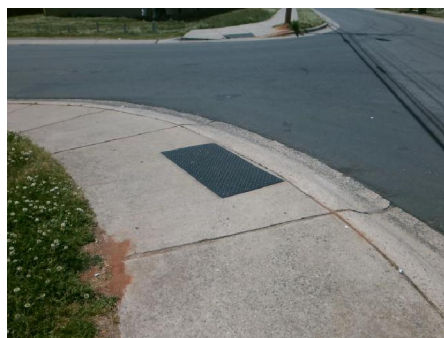
Not Found, R304.5.3

Compliance	Description	Data	Compliance	Description	Data
N/A	Ramp Length (in)	61.5	Yes	BlendTrans Slope (%)	4.0
Yes	Ramp Width (in)	98.0	No	BlendTrans XSlope (%)	5.5
N/A	Flare Type LT	N/A	N/A	Flare Type RT	N/A
N/A	Flare Slope LT (%)	N/A	N/A	Flare Slope RT (%)	N/A
N/A	Flare Traversable LT?	N/A	N/A	Flare Traversable RT?	N/A
N/A	Landing Length (in)	N/A	N/A	DWS Provided?	N/A
N/A	Landing Width (in)	N/A	N/A	DWS Contrast?	N/A
N/A	Landing Slope (%)	N/A	N/A	DWS Length (in)	N/A
N/A	Landing X Slope (%)	N/A	N/A	DWS Full Width?	N/A
N/A	Landing Curb? (Y/N)	N/A	N/A	DWS Offset (in)	N/A
N/A	Shared Landing?	N/A			
N/A	Gutter Ponding?	N/A	N/A	Gutter Slope (%)	N/A
N/A	Gutter Lip Ht (in)	N/A	N/A	Gutter X Slope (%)	N/A
N/A	Painted X Walk1?	No	N/A	Painted X Walk2?	No
	X Walk 1 Direction	To N		X Walk 2 Direction	To W
	X Walk 1 Width (in)	N/A		X Walk 2 Width (in)	N/A
	X Walk 1 Slope (%)	3.1		X Walk 2 Slope (%)	2.5
	X Walk 1 X Slope (%)	1.0		X Walk 2 X Slope (%)	4.7

N/A	Ramp inside XWalk1?	N/A	N/A	Ramp inside XWalk2?	N/A
	Road Slope (%)	2.5		Clear Space?	N/A
	Road X Slope (%)	5.9	N/A	Clear Space to XWalk (in)	N/A
N/A	Any Obstructions?	N/A	N/A	Storm Grate/Utility Hazard?	N/A
	Obstruction Type			Storm Grate/Utility Type	
		N/A			N/A
			Yes	Surface Condition? (G/P)	Good
			No	Curb Slope (%)	24.2

Remove & Replace Curb Ramp With Two New Directional Ramps or Equivalent.
