| Intersection ID: 1000791 | Main Street: BELL'S_MILL_DR | Cross Street: N/A | Location: | N |
| ADA ID: F837423F7373 | Ramp Type: Perp | Initial Pass/Fail: Fail | Overall Compliance: No | Severity Score: 25 |

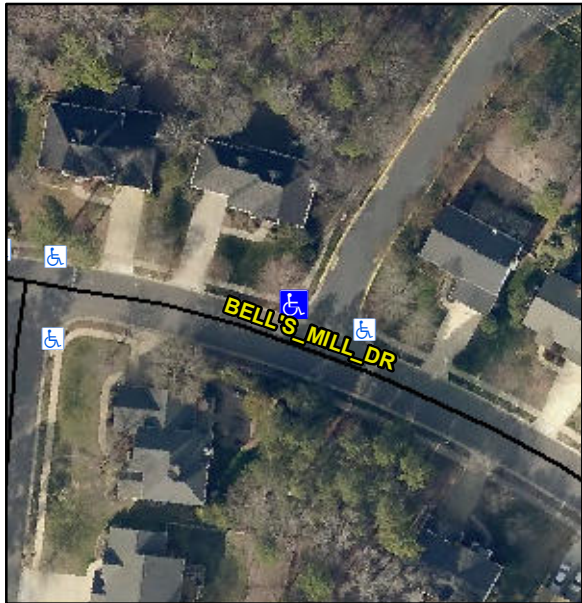
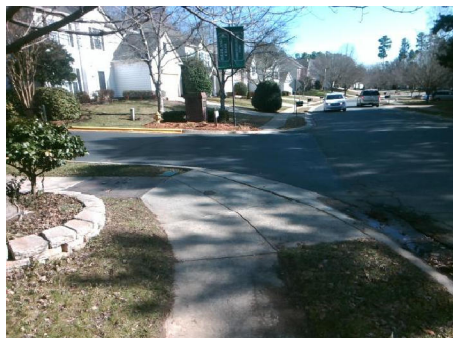
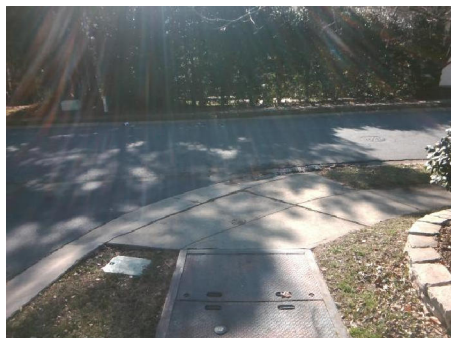
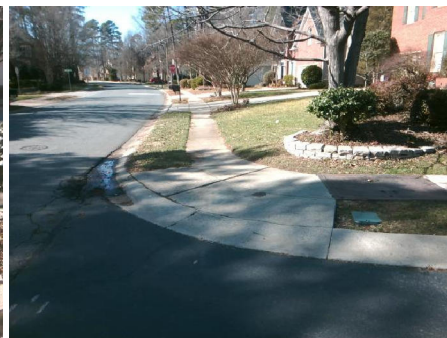
| Codes/Mitigation Info/Possible Solution | | | Field Measurements/Component Compliance | | | | | |
|---|---|--|---|---|---|---|---|---|
| | | | Yes | Ramp Width (in) | 111.5 | No | Ramp XSlope (%) | 7.0 |
| | Not Found, R304.5.3 | | N/A | Gutter Lip Ht (in) | N/A | N/A | Gutter X Slope (%) | N/A |

| Codes/Mitigation Info/Possible Solution | | | Field Measurements/Component Compliance | | | | | |
|---|---|--|---|---|---|---|---|---|
| | Remove & Replace Entire Ramp. | | N/A | Ramp Length (in) | 45.0 | Yes | Ramp Slope (%) | 7.2 |
