Access Compliance Report Public Rights-of-Way (Curb Ramps)

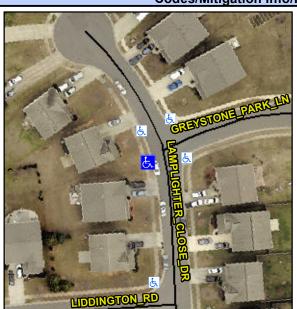
Intersection ID: 47274 Main Street: GREYSTONE_PARK_LN Cross Street: LAMPLIGHTER_CLOSE_DR Location: SW ADA ID: F837DD9482D6 Ramp Type: Perp Initial Pass/Fail: Fail **Overall Compliance: No** Severity Score: 18.75

Possible Solution			Fleid Measurements/Component Compilance						
Possible Solutions:			Compliance Description			Comp	liance Description	Data	
Remove & Replace	Entire Ramı	D.	N/A	Ramp Length (in)	48.5	Yes	Ramp Slope (%)	6.6

•	-	No	Ramp Width (in)	35.0	Yes	Ramp XSlope (%)	2.7	
			N/A	Flare Type LT	N/A	N/A	Flare Type RT	N/A	
			N/A	Flare Slope LT (%)	N/A	N/A	Flare Slope RT (%)	N/A	
			N/A	Flare Traversable LT?	N/A	N/A	Flare Traversable RT?	N/A	
			N/A	Landing Length (in)	N/A	N/A	DWS Provided?	N/A	
Surveyor Notes:			N/A	Landing Width (in)	N/A	N/A	DWS Contrast?	N/A	
N/A			N/A	Landing Slope (%)	N/A	N/A	DWS Length (in)	N/A	
			N/A	Landing X Slope (%)	N/A	N/A	DWS Full Width?	N/A	
			N/A	Landing Curb? (Y/N)	N/A	N/A	DWS Offset (in)	N/A	
			N/A	Shared Landing?	N/A				
PROW/ADA:			N/A	Gutter Ponding?	N/A	N/A	Gutter Slope (%)	N/A	
Not Found, R304.5.	1		N/A	Gutter Lip Ht (in)	N/A	N/A	Gutter X Slope (%)	N/A	
·			N/A	Painted X Walk1?	No	N/A	Painted X Walk2?	N/A	
				X Walk 1 Direction	To E		X Walk 2 Direction	N/A	
			N/A	X Walk 1 Width (in)	N/A	N/A	X Walk 2 Width (in)	N/A	
				X Walk 1 Slope (%)	2.9		X Walk 2 Slope (%)	N/A	
				X Walk 1 X Slope (%)	3.1		X Walk 2 X Slope (%)	N/A

N/A	Ramp inside XWalk1?	N/A	N/A	Ramp inside XWalk2?	N/A	
				Road Slope (%)	N/A	N/A	Clear Space?	N/A	
				Road X Slope (%)	N/A	N/A	Clear Space to XWalk (in)	N/A	
			N/A	Any Obstructions?	N/A	N/A	Storm Grate/Utility Hazard?	N/A	
Total Cost:	\$	1850.00		Obstruction Type		l	Storm Grate/Utility Type		
					N/A			N/A	
						Yes	Surface Condition? (G/P)	Good
