Access Compliance Report

Public Rights-of-Way

(Curb Ramps)

Intersection ID: 7852	Main Street: JARMON_CT	Cross Street: SNOW_WHITE_LN	Location: SE
ADA ID: F842253B88D5	Ramp Type: BlendTrans1	Initial Pass/Fail: Fail	Overall Compliance: No
		Severity Score: 1.25

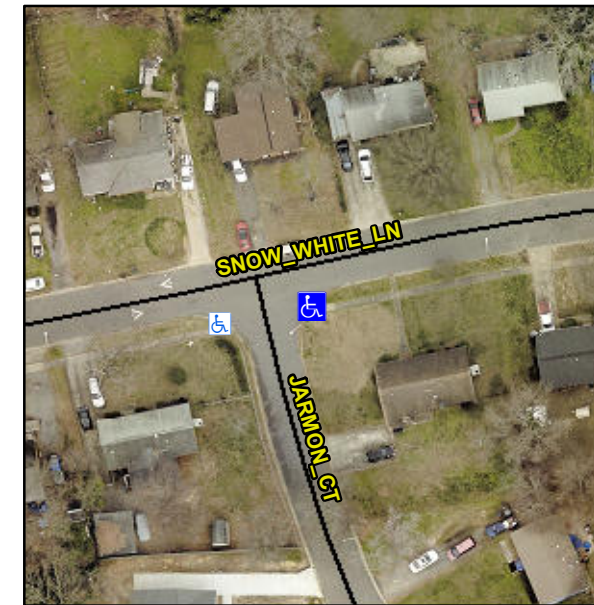
Not Found, R304.5.3

Remove & Replace Curb Ramp With Two New Directional Ramps or Equivalent.

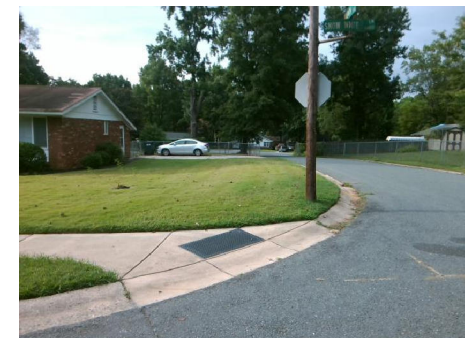
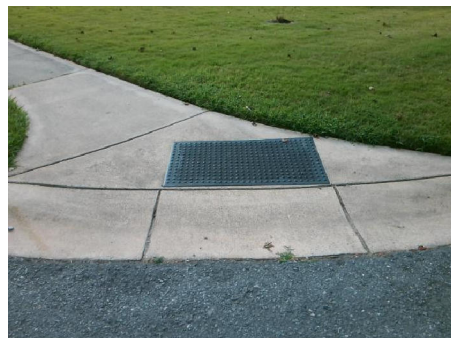
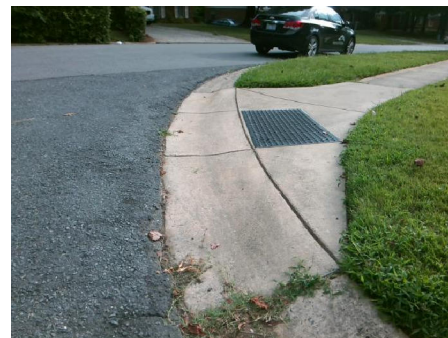
Compliance	Description	Data	Compliance	Description	Data
N/A	Ramp Length (in)	28.5	Yes	BlendTrans Slope (%)	3.5
Yes	Ramp Width (in)	49.0	No	BlendTrans XSlope (%)	3.5
N/A	Flare Type LT	N/A	N/A	Flare Type RT	N/A
N/A	Flare Slope LT (%)	N/A	N/A	Flare Slope RT (%)	N/A
N/A	Flare Traversable LT?	N/A	N/A	Flare Traversable RT?	N/A
N/A	Landing Length (in)	N/A	N/A	DWS Provided?	N/A
N/A	Landing Width (in)	N/A	N/A	DWS Contrast?	N/A
N/A	Landing Slope (%)	N/A	N/A	DWS Length (in)	N/A
N/A	Landing X Slope (%)	N/A	N/A	DWS Full Width?	N/A
N/A	Landing Curb? (Y/N)	N/A	N/A	DWS Offset (in)	N/A
N/A	Shared Landing?	N/A			
N/A	Gutter Ponding?	N/A	N/A	Gutter Slope (%)	N/A
N/A	Gutter Lip Ht (in)	N/A	N/A	Gutter X Slope (%)	N/A
N/A	Painted X Walk1?	No	N/A	Painted X Walk2?	N/A
	X Walk 1 Direction	To SW		X Walk 2 Direction	N/A
	X Walk 1 Width (in)	N/A		X Walk 2 Width (in)	N/A
	X Walk 1 Slope (%)	2.9		X Walk 2 Slope (%)	N/A
	X Walk 1 X Slope (%)	1.3		X Walk 2 X Slope (%)	N/A

N/A	Ramp inside XWalk1?	N/A	N/A	Ramp inside XWalk2?	N/A
	Road Slope (%)	1.3		Clear Space?	N/A
	Road X Slope (%)	2.9	N/A	Clear Space to XWalk (in)	N/A
N/A	Any Obstructions?	N/A	N/A	Storm Grate/Utility Hazard?	N/A
	Obstruction Type			Storm Grate/Utility Type	
		N/A			N/A
			Yes	Surface Condition? (G/P)	Good
			No	Curb Slope (%)	16.7
