Access Compliance Report

Public Rights-of-Way

(Curb Ramps)

Intersection ID: 5638	Main Street: BELLHAVEN_BV	Cross Street: KENTBERRY_DR	Location:	N
ADA ID: F848802BA255	Ramp Type: Perp	Initial Pass/Fail: Fail	Overall Compliance: No	Severity Score: 8.75
Codes/Mitigation Info/Possible Solution		Field Measurements/Component Compliance

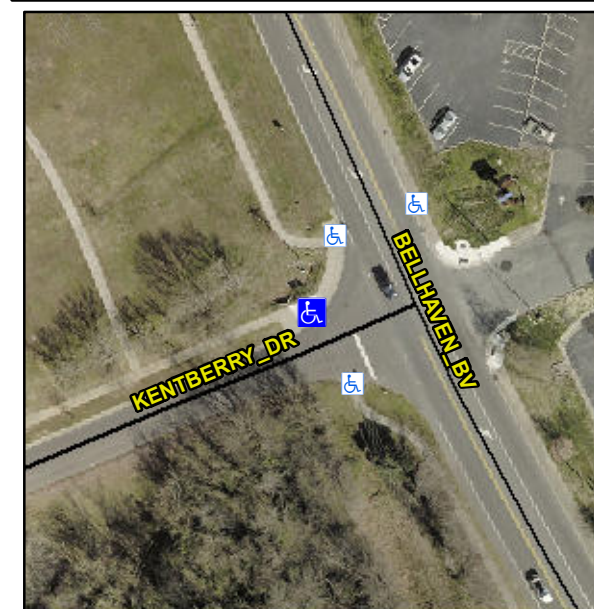
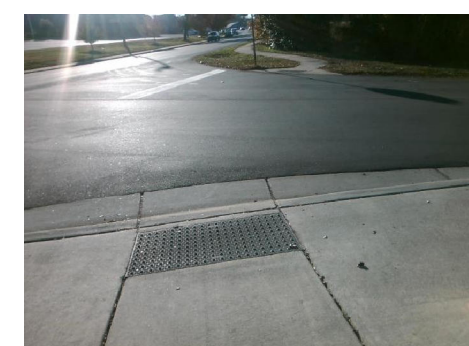
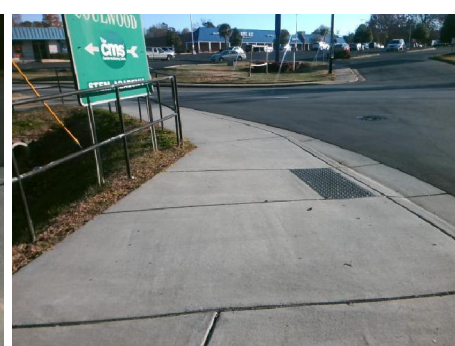
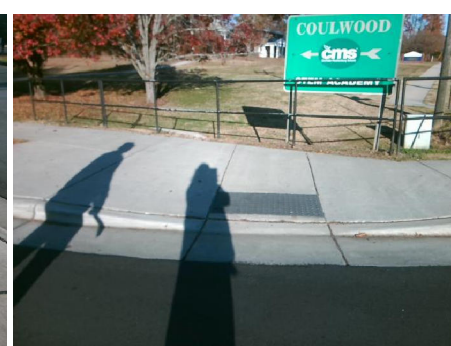
Not Found, R304.5.1

Compliance	Description	Data	Compliance	Description	Data
N/A	Ramp Length (in)	63.0	Yes	Ramp Slope (%)	6.8
No	Ramp Width (in)	47.0	Yes	Ramp XSlope (%)	0.0
N/A	Flare Type LT	N/A	N/A	Flare Type RT	N/A
N/A	Flare Slope LT (%)	N/A	N/A	Flare Slope RT (%)	N/A
N/A	Flare Traversable LT?	N/A	N/A	Flare Traversable RT?	N/A
N/A	Landing Length (in)	N/A	N/A	DWS Provided?	N/A
N/A	Landing Width (in)	N/A	N/A	DWS Contrast?	N/A
N/A	Landing Slope (%)	N/A	N/A	DWS Length (in)	N/A
N/A	Landing X Slope (%)	N/A	N/A	DWS Full Width?	N/A
N/A	Landing Curb? (Y/N)	N/A	N/A	DWS Offset (in)	N/A
N/A	Shared Landing?	N/A			
N/A	Gutter Ponding?	N/A	N/A	Gutter Slope (%)	N/A
N/A	Gutter Lip Ht (in)	N/A	N/A	Gutter X Slope (%)	N/A
N/A	Painted X Walk1?	No	N/A	Painted X Walk2?	N/A
	X Walk 1 Direction	To S		X Walk 2 Direction	N/A
N/A	X Walk 1 Width (in)	N/A	N/A	X Walk 2 Width (in)	N/A
	X Walk 1 Slope (%)	2.2		X Walk 2 Slope (%)	N/A
	X Walk 1 X Slope (%)	1.3		X Walk 2 X Slope (%)	N/A

N/A	Ramp inside XWalk1?	N/A	N/A	Ramp inside XWalk2?	N/A
	Road Slope (%)	N/A	N/A	Clear Space?	N/A
	Road X Slope (%)	N/A	N/A	Clear Space to XWalk (in)	N/A
N/A	Any Obstructions?	N/A	N/A	Storm Grate/Utility Hazard?	N/A
	Obstruction Type			Storm Grate/Utility Type	
		N/A			N/A
			Yes	Surface Condition? (G/P)	Good

Remove & Replace Entire Ramp.
